Historical Structure Assessment

East Maui Aqueduct System

Mason Architects, Inc.

April 2019

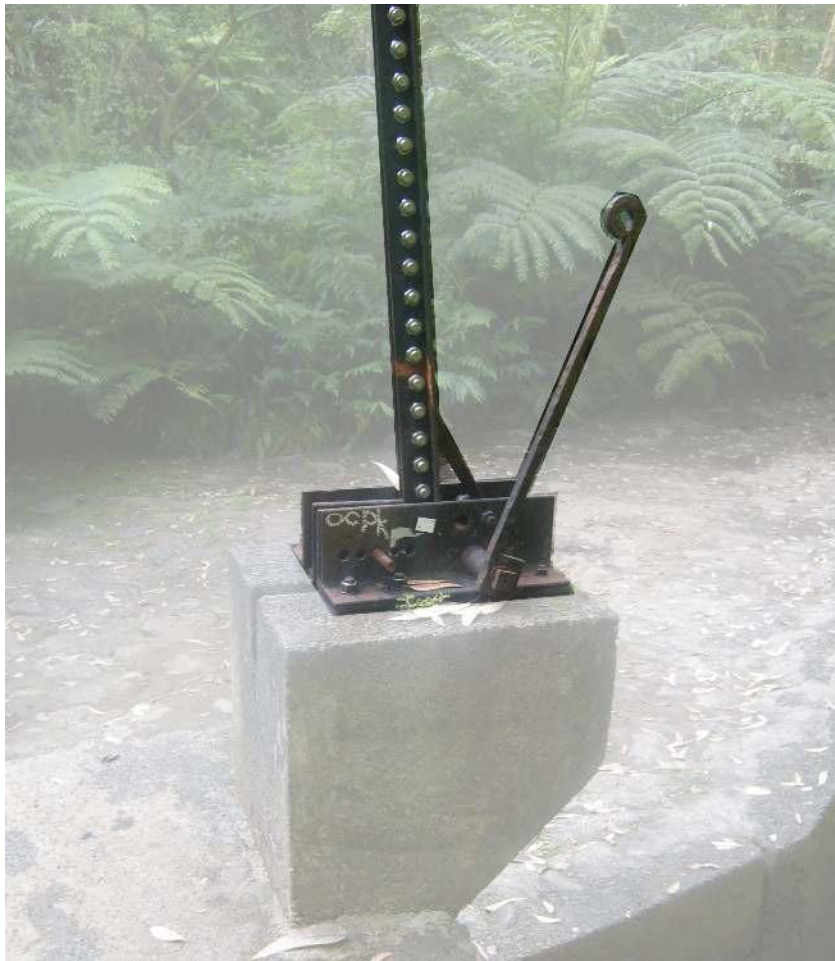
Figure 24: This typical ratchet type sluice gate operating mechanism is located at EMI Hoolawaili Stream diversion, on a tributary of Hoolawa, which is ordered to be restored as a “Habitat Stream” by CWRM. View facing SE. (Source: MAI, 2018.)

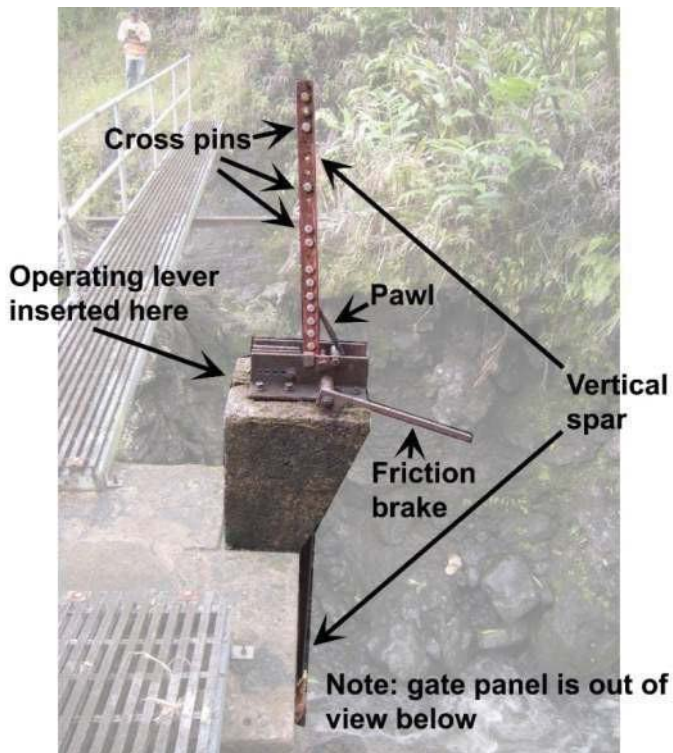
Figure 26: This photo illustrates the parts of the sluice gate. Existing modifications to ratchet type sluice gates include the replacement of cross pins (sometimes with stainless steel pins), and placing a locked box over the operating lever area to prevent unauthorized gate adjustments. The integrity of this type of gate can also be affected by the removal of operating parts by EMI to disable the gate, and by corrosion, which can degrade parts and cause them to break or come loose. (Source: MAI, 2018.)

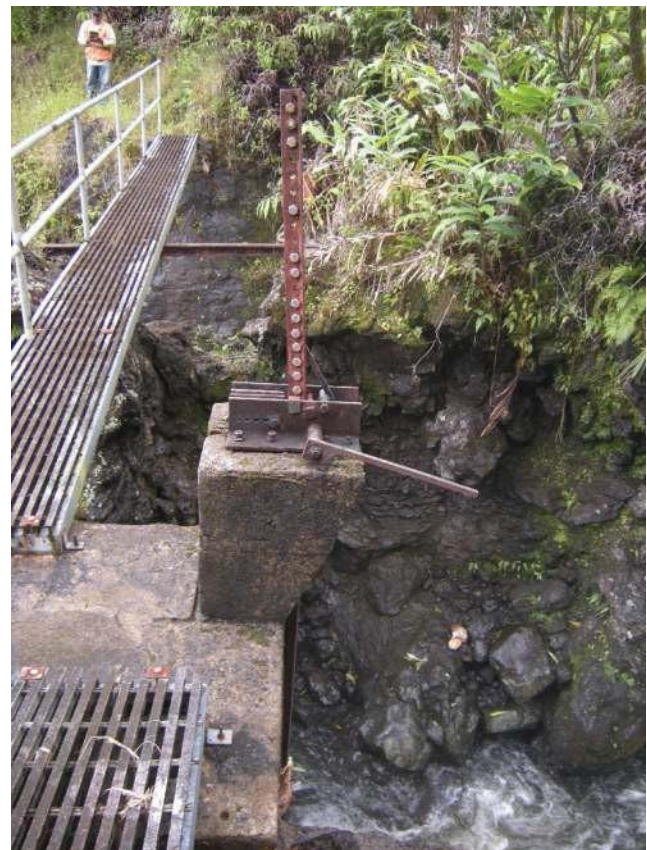
Figure 25: This sluice gate mechanism is a ratchet type. The concrete pedestal and platform it is mounted on is typical of ratchet type gate mechanisms. This ratchet-operating gate is located at EMI stream diversion at Makapipi, which was fully restored in 2008. View facing SE. (Source: MAI, 2018.)

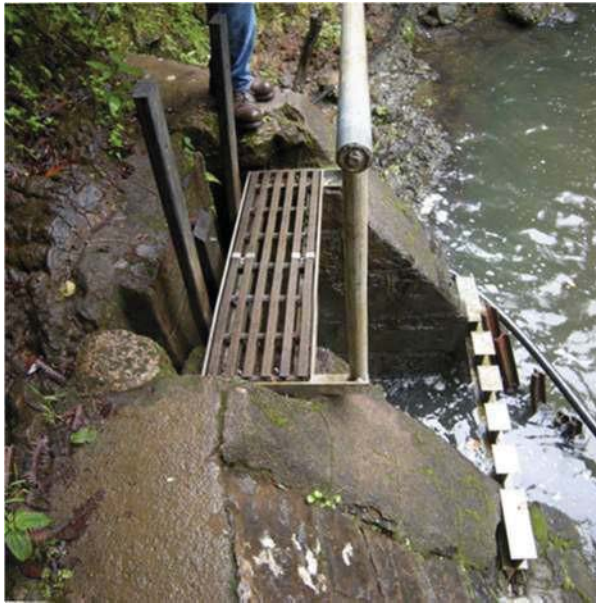
Figure 32: Board adjusted sluice gate with plastic boards installed. Boards are in the closed position, preventing water from passing through the gate. At about 2'-6" wide, this gate is typical width for board adjusted gates seen at EMI during the field survey. This board adjusted gate is located at EMI stream diversion at Waiohue, which is ordered to be a "Fully Restored" stream by CWRM. View facing SE. (Source: MAI, 2018.)

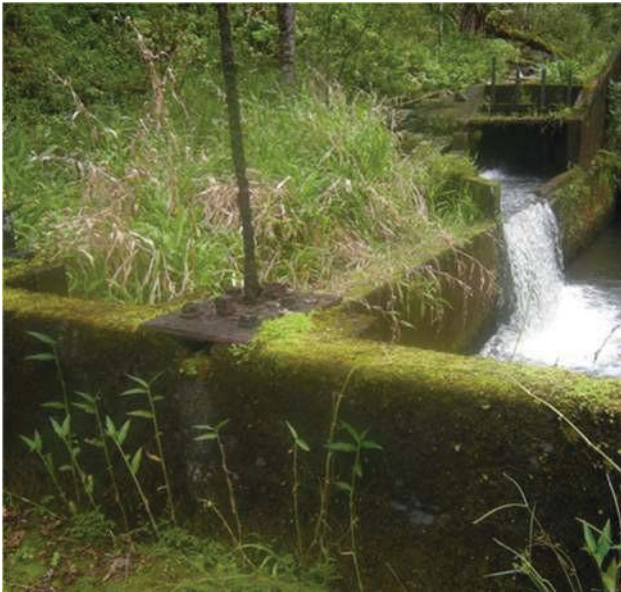
Figure 34: The sluice gate mechanism is a threaded shaft type that is inoperable due to corroded and missing parts. The gate once operated by turning a handwheel that advanced the formerly threaded vertical steel shaft up and down, moving the metal panel. The handwheel is missing and corrosion has destroyed the threads on the steel shaft. Some of these mechanisms have become inoperable due to lack of use. When necessary, however, they can be serviced to make the adjustments. This threaded shaft gate is located at EMI stream diversion at Kolea Power House, on Kolea, a tributary of Punalau, which is ordered to be restored as a “Habitat Stream” by CWRM. View facing S. (Source: MAI, 2018.)

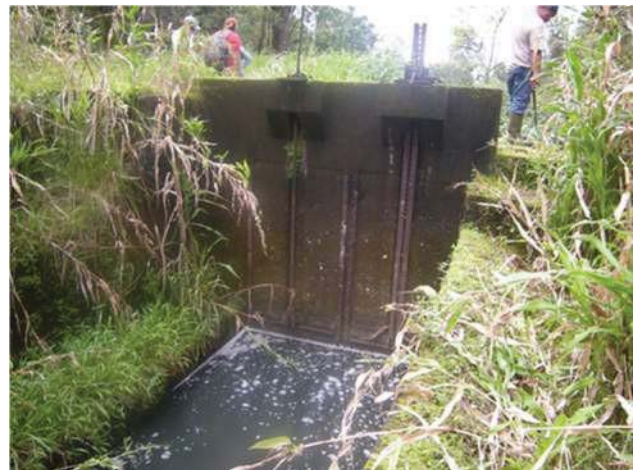
Figure 35: Another view of the threaded shaft gate mechanism at left. This gate is paired with a ratchet type gate. (Source: MAI, 2018.)

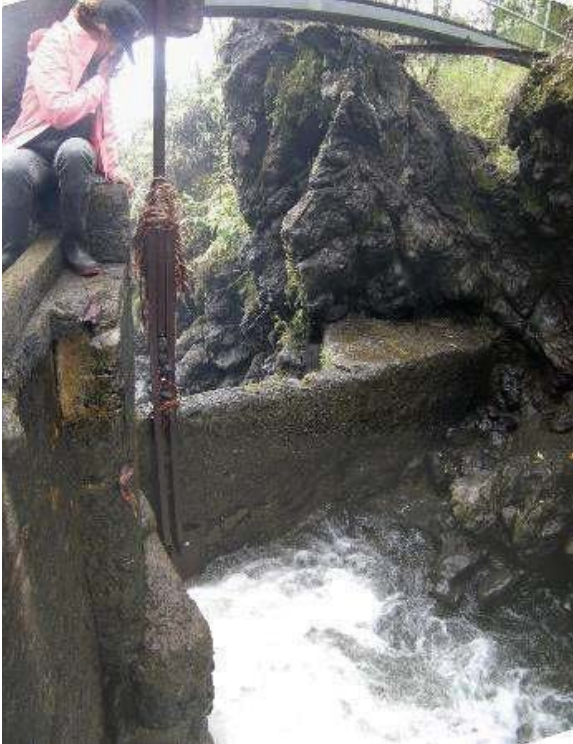
Figure 1: Ratchet sluice gate at Makapipi stream diversion dam. Eligible for the Hawaii Register as a contributing feature to a potential district. Integrity largely retained. View facing SE. (Source: MAI, 2018)

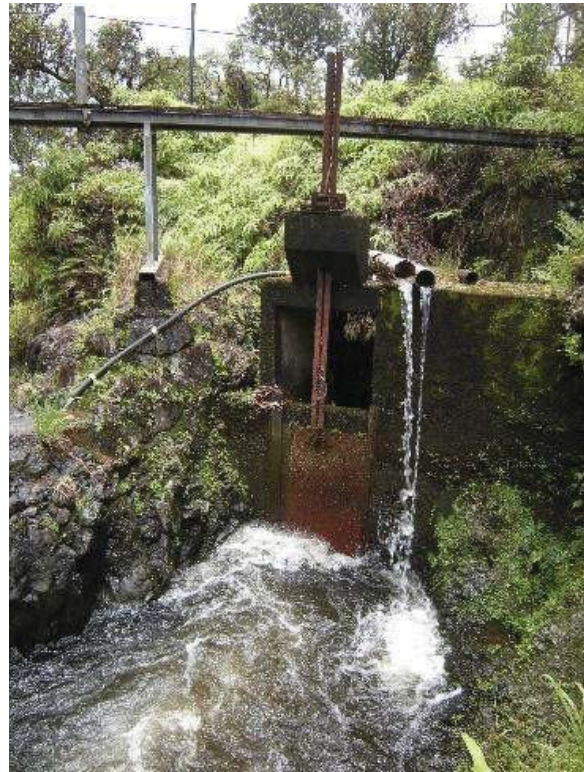
Figure 2: Ratchet sluice gate at Hanawi stream diversion dam. Eligible for the Hawaii Register as a contributing feature to a potential district. Integrity largely retained. View facing NE. (Source: MAI, 2018)

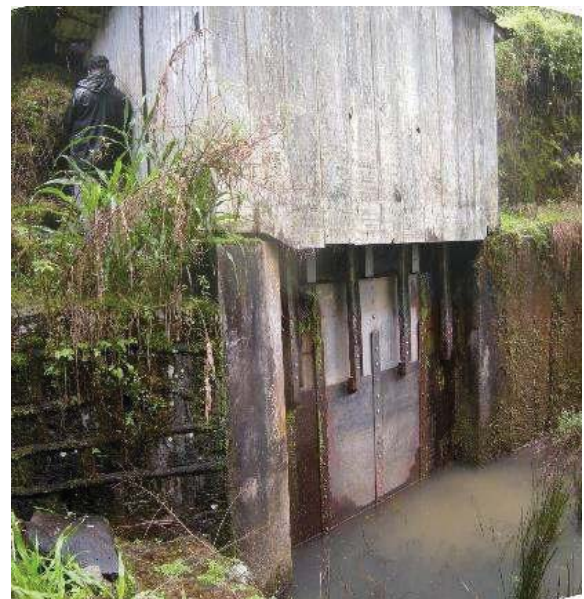
Figure 4: Geared sluice gate at intake at Ko Piliula stream diversion. Eligible for the Hawaii Register as a contributing feature to a potential district. Integrity partially retained. View facing NE. (Source: MAI, 2018)

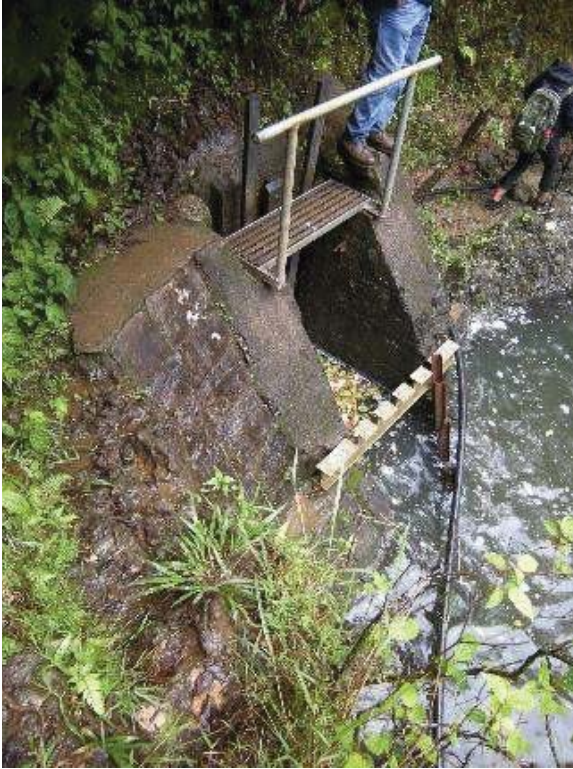
Figure 5: Board adjusted sluice gate at intake of Wai O Hue stream diversion. Eligible for the Hawaii Register as a contributing feature to a potential district. Integrity partially retained. View facing S. (Source: MAI, 2018)

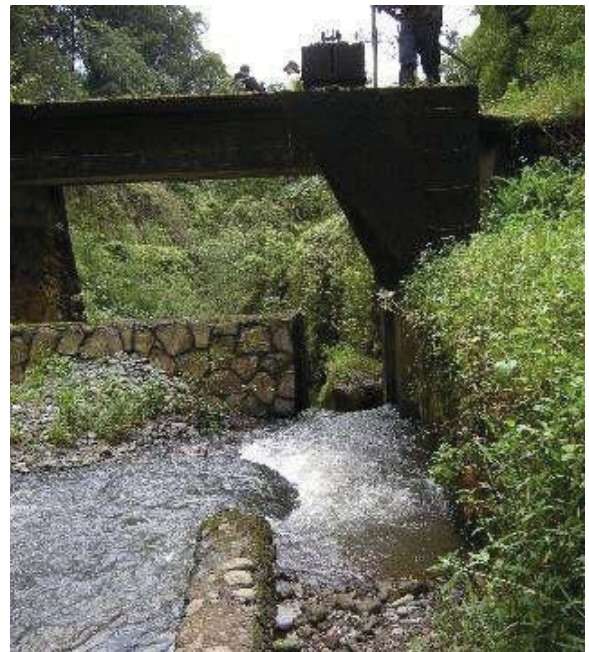
Figure 8: Removed sluice gate (ratchet) at Wailua Nui West stream diversion dam. Eligible for the Hawaii Register as a contributing feature to a potential district. Integrity largely retained. View facing NE. (Source: MAI, 2018)

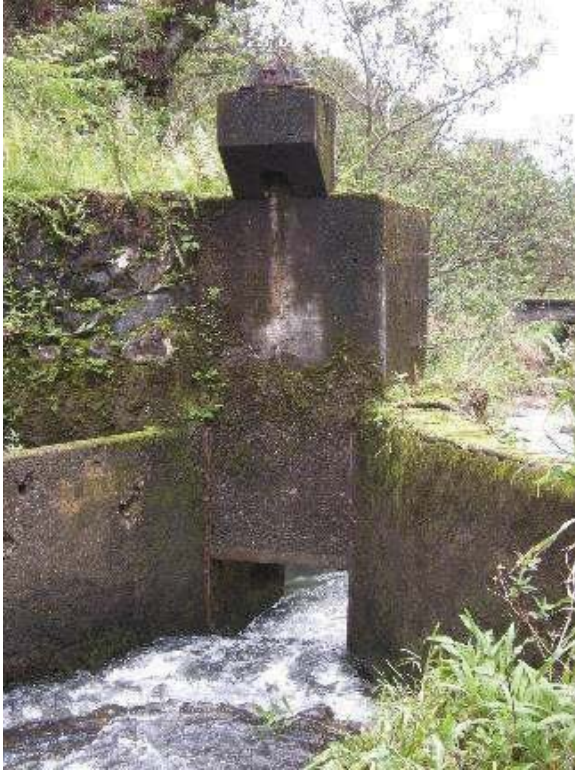
Figure 9: Removed sluice gate (ratchet) at Wailua Nui East stream diversion dam. Eligible for the Hawaii Register as a contributing feature to a potential district. Integrity largely retained. View facing NE. (Source: MAI, 2018)

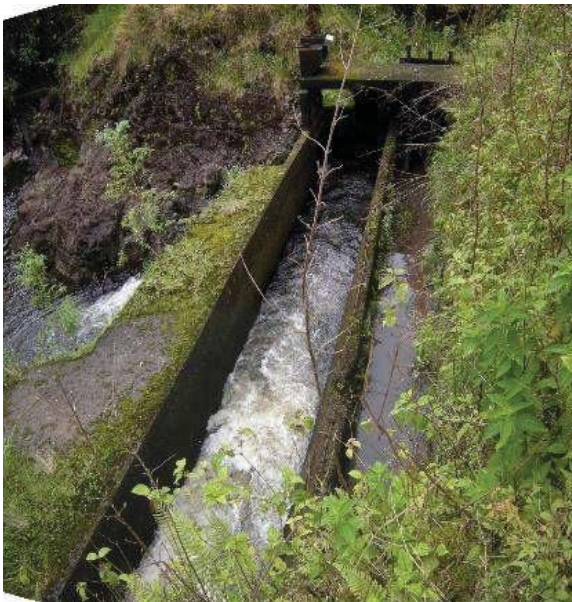
Figure 11: Board adjusted sluice gate at intake of Wailua Iki West stream diversion. Eligible for the Hawaii Register as a contributing feature to a potential district. Integrity largely retained. View facing NE. (Source: MAI, 2018)

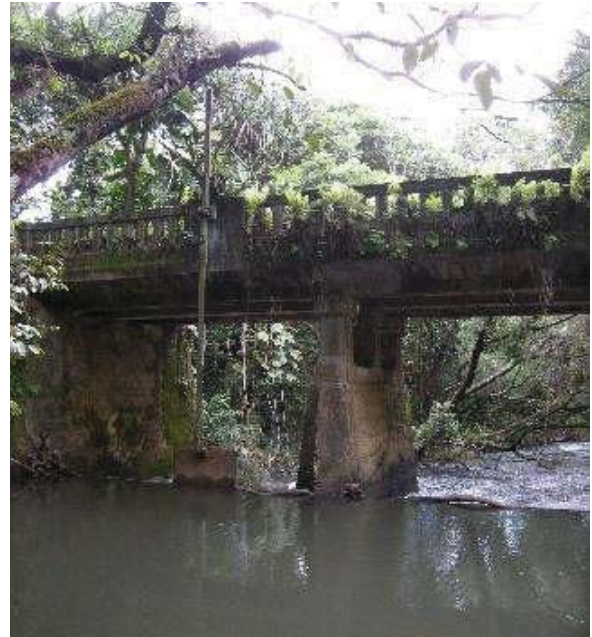
Figure 14: Geared sluice gate at Hoolawa Haiku stream diversion dam. Eligible for the Hawaii Register as a contributing feature to a potential district. Integrity partially retained. View facing NW. (Source: MAI, 2018)

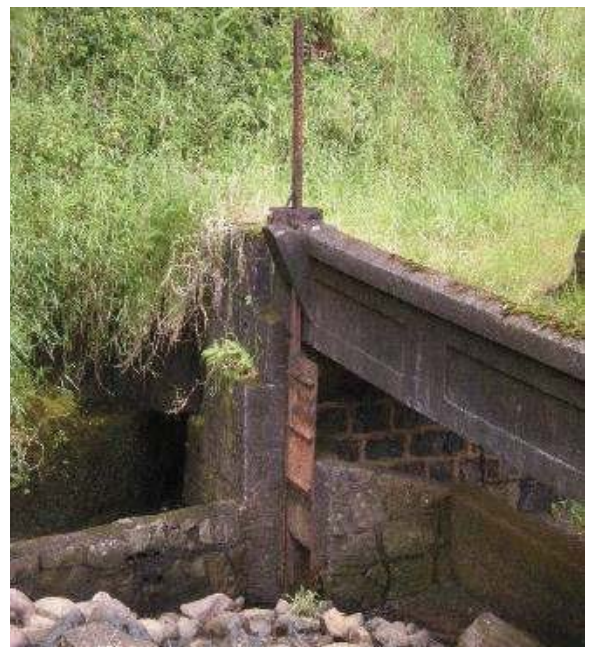
Figure 16: Ratchet sluice gate at Banana Intake stream diversion dam. Eligible for the Hawaii Register as a contributing feature to a potential district. Integrity largely retained. View facing NW. (Source: MAI, 2018)

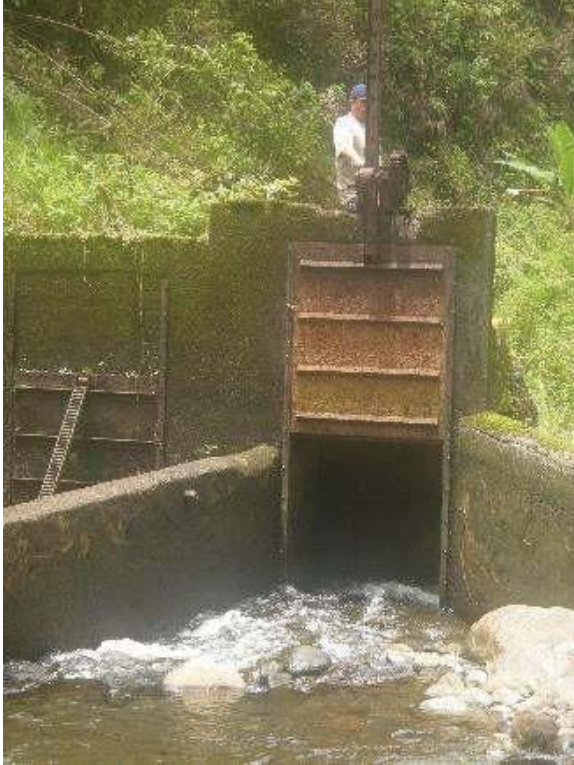
Figure 17: Geared sluice gate at Honomanu stream diversion dam. Eligible for the Hawaii Register as a contributing feature to a potential district. Integrity largely retained. View facing N. (Source: MAI, 2018)

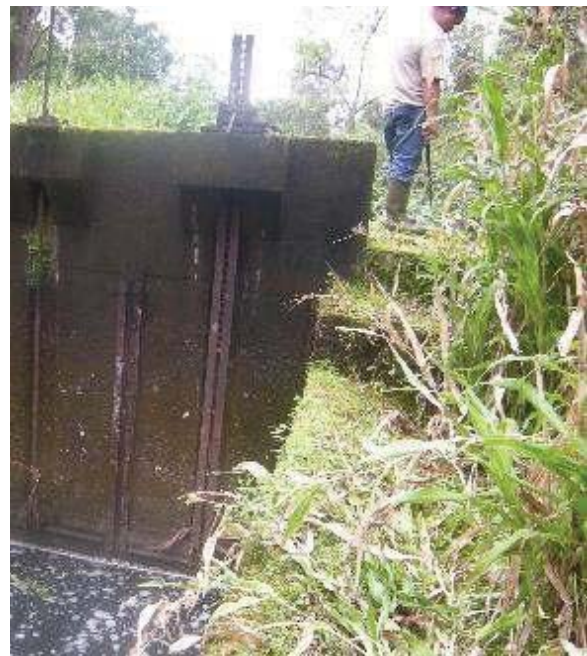
Figure 20: Ratchet sluice gate throw out at intake of Kolea Power House stream diversion. Eligible for the Hawaii Register as a contributing feature to a potential district. Integrity largely retained. View facing N. (Source: MAI, 2018)

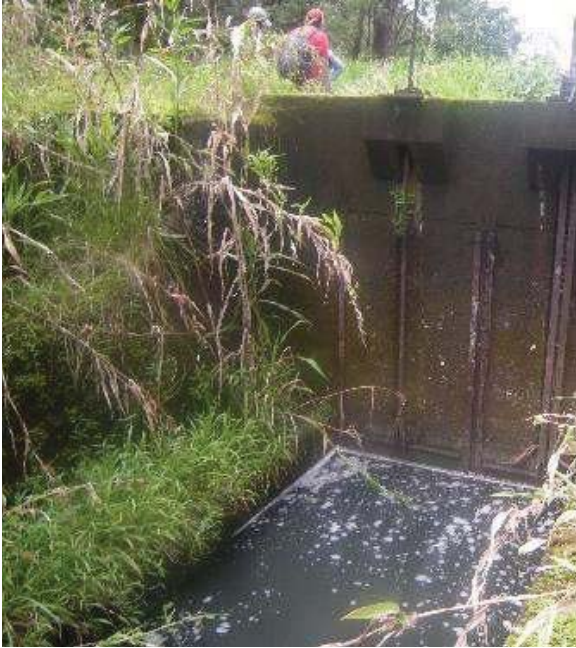
Figure 21: Threaded shaft sluice gate throw out (on left) at intake of Kolea Power House stream diversion. Eligible for the Hawaii Register as a contributing feature to a potential district. Integrity largely retained. View facing N. (Source: MAI, 2018)

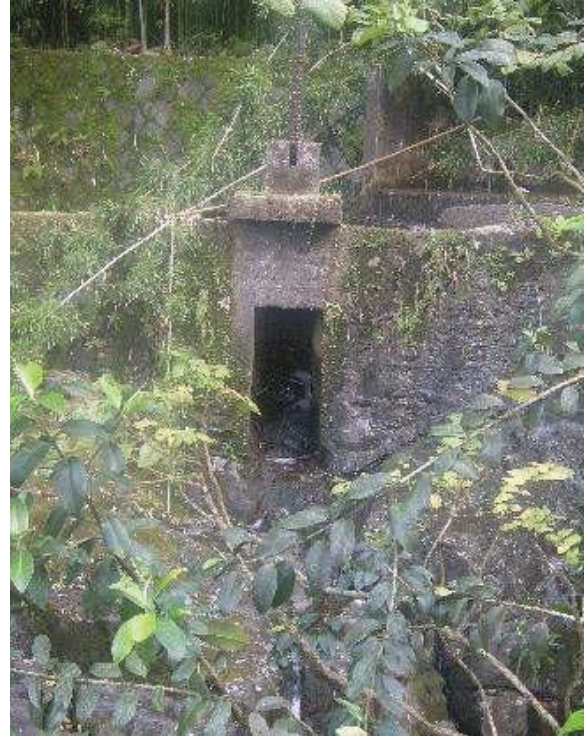
Figure 22: Ratchet sluice gate throw out at Kaaiea stream diversion. Eligible for the Hawaii Register as a contributing feature to a potential district. Integrity largely retained. View facing S. (Source: MAI, 2018)

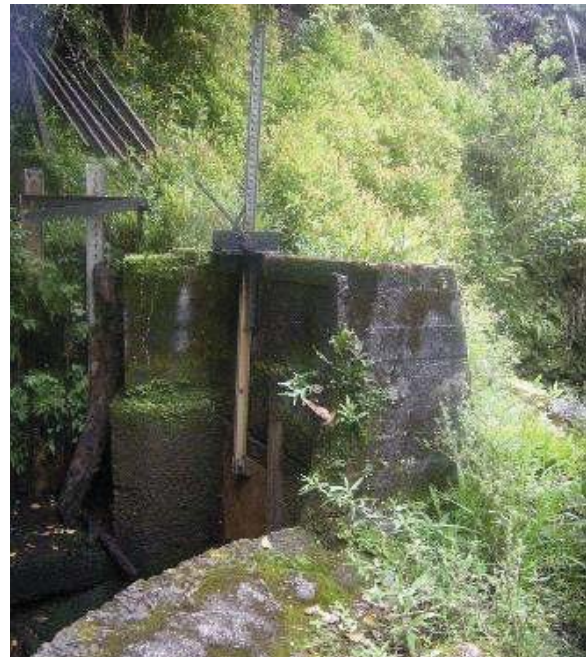
Figure 24: Ratchet sluice gate throw out at intake of Hoalua stream diversion. Eligible for the Hawaii Register as a contributing feature to a potential district. Integrity largely retained. View facing NE. (Source: MAI, 2018)

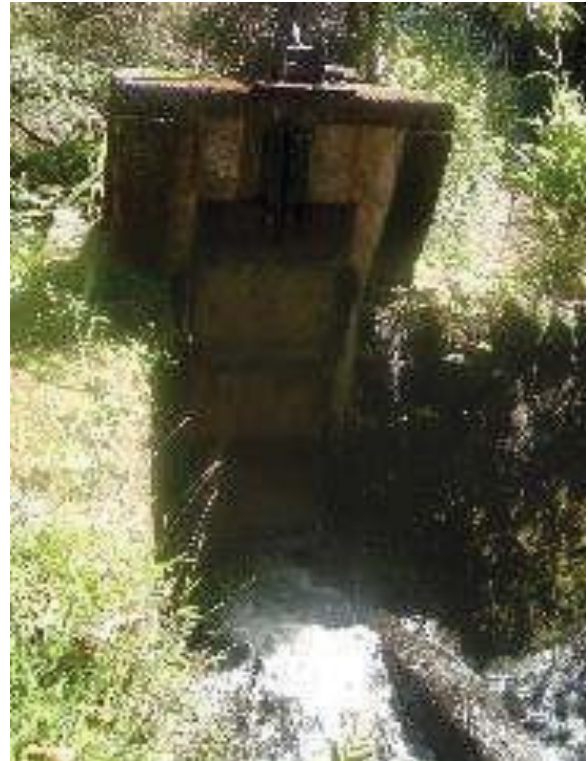
Figure 26: Ratchet sluice gate throw out at intake of Hoolawa Nui stream diversion. Eligible for the Hawaii Register as a contributing feature to a potential district. Integrity largely retained. View facing S. (Source: MAI, 2018)

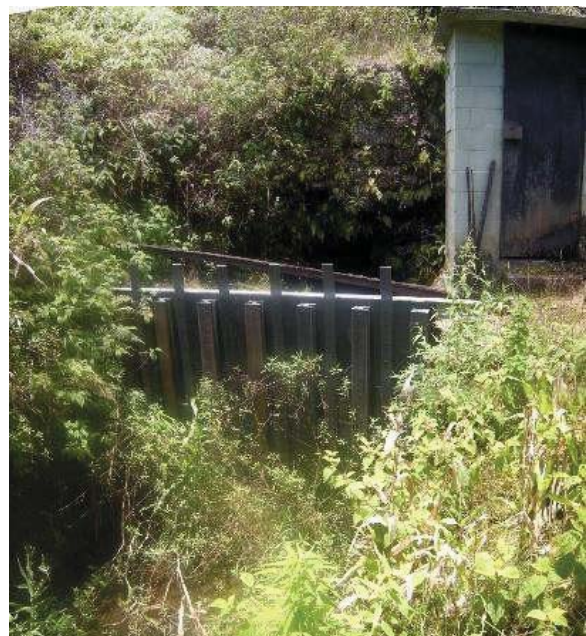
Figure 28: Board adjusted sluice gate at Piinaau throw out. Eligible for the Hawaii Register as a contributing feature to a potential district. Integrity partially retained. View facing SW. (Source: MAI, 2018)

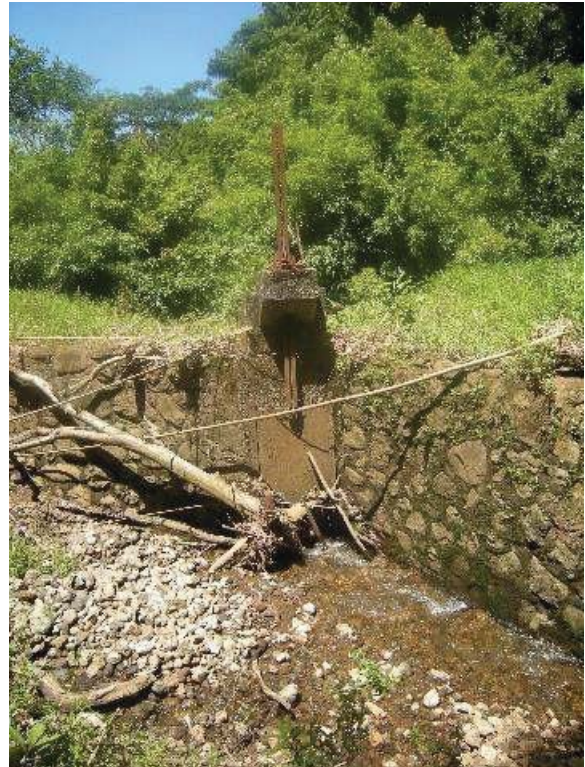
Figure 30: Ratchet sluice gate at Kolea stream diversion dam. Eligible for the Hawaii Register as a contributing feature to a potential district. Integrity largely retained. View facing NE. (Source: MAI, 2018)
