Historical Structure Assessment

East Maui Aqueduct System

Mason Architects, Inc.

April 2019

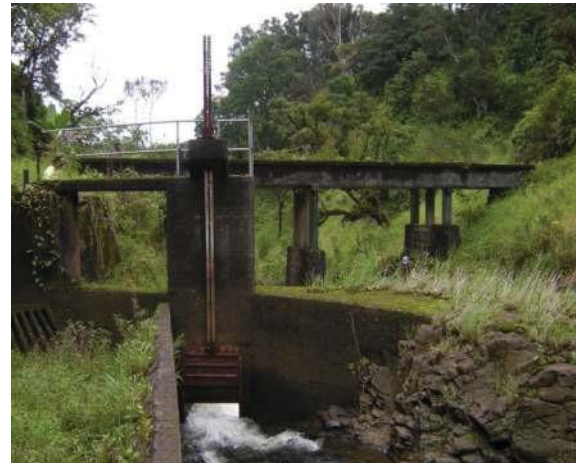
Figure 21: Typical sluice gate. Note the vertically sliding panel at the lower end that is operated by the mechanism above. This ratchet-operating gate is located at EMI stream diversion at Wailuaki East, which is ordered to be restored as a “Habitat Stream” by CWRM. (Source: MAI, 2018.)

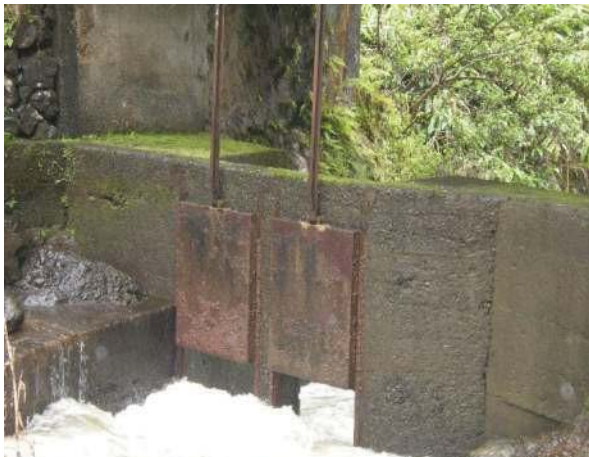
Figure 23: Typical board adjusted type sluice gate mechanism, shown with the gate closed. This gate is located at EMI stream diversion at Waiohue, which is ordered to be a “Fully Restored” stream by CWRM. View facing SE. (Source: MAI, 2018.)

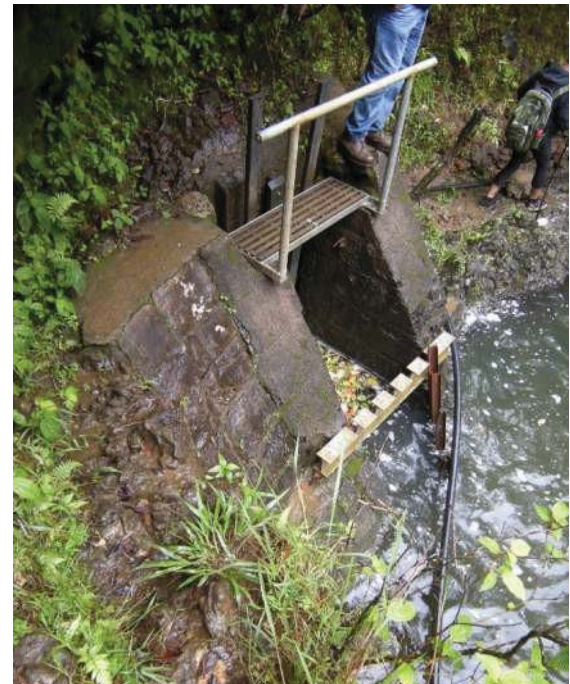
Figure 22: Typical configuration of sluice gates in a concrete dam. These sluice gates are located at EMI stream diversion at Kopiliula, which is ordered to be restored as a “Habitat Stream” by CWRM. View facing N. (Source: MAI, 2018.)

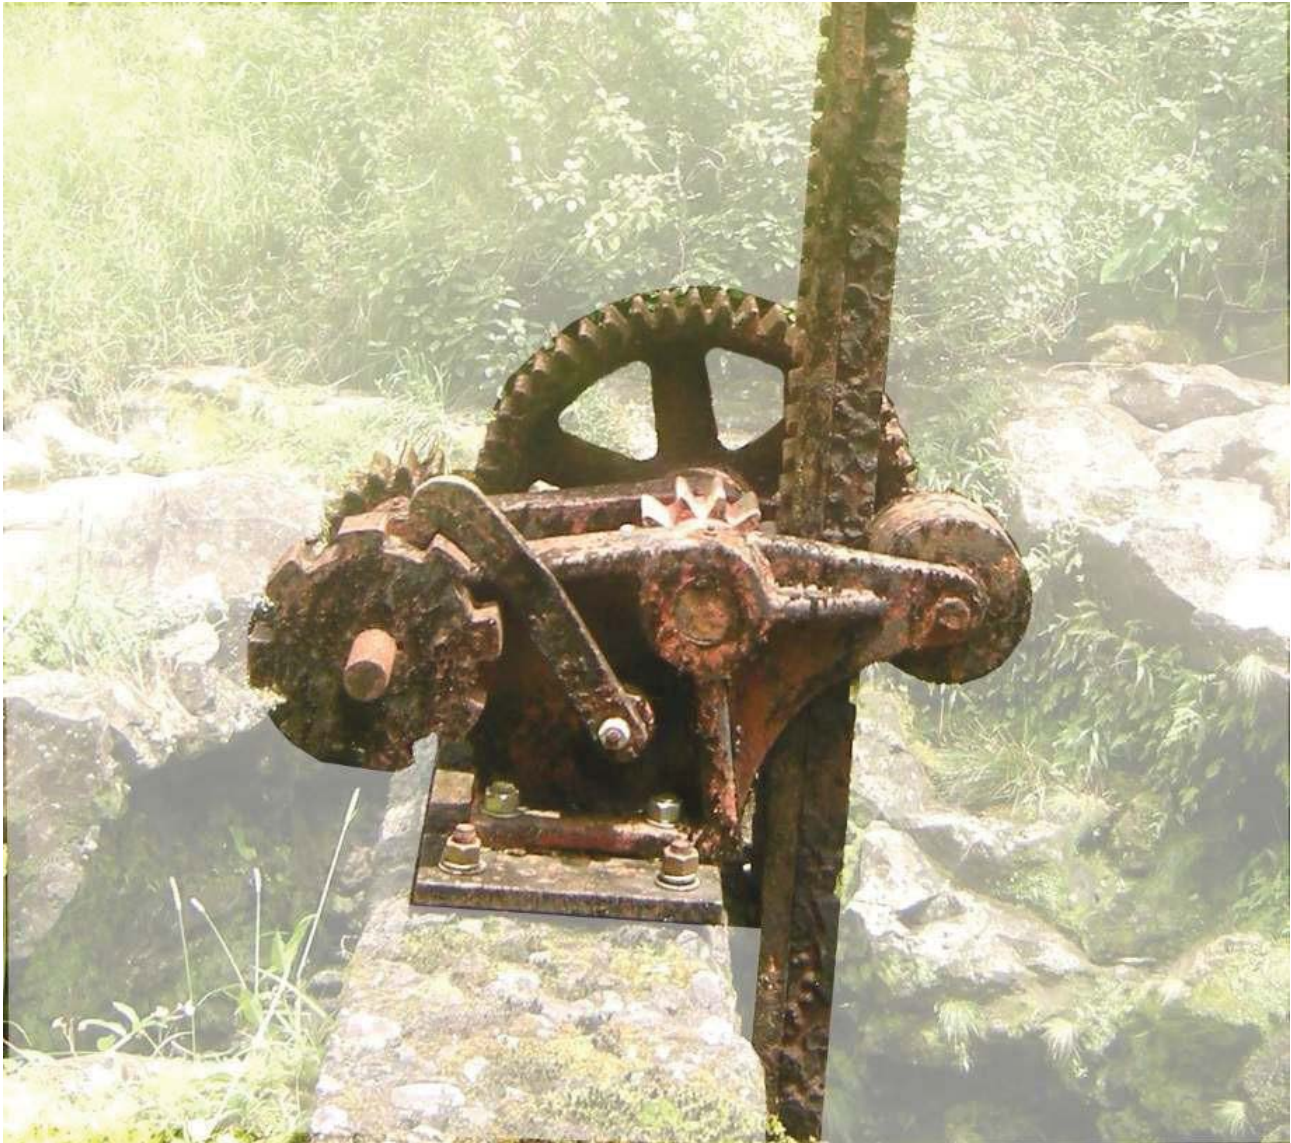
Figure 27: This typical geared type sluice gate operating mechanism is located at EMI Honomanu Stream diversion, which is ordered to be restored as a “Habitat Stream” by CWRM. View facing SE. (Source: MAI, 2018.)

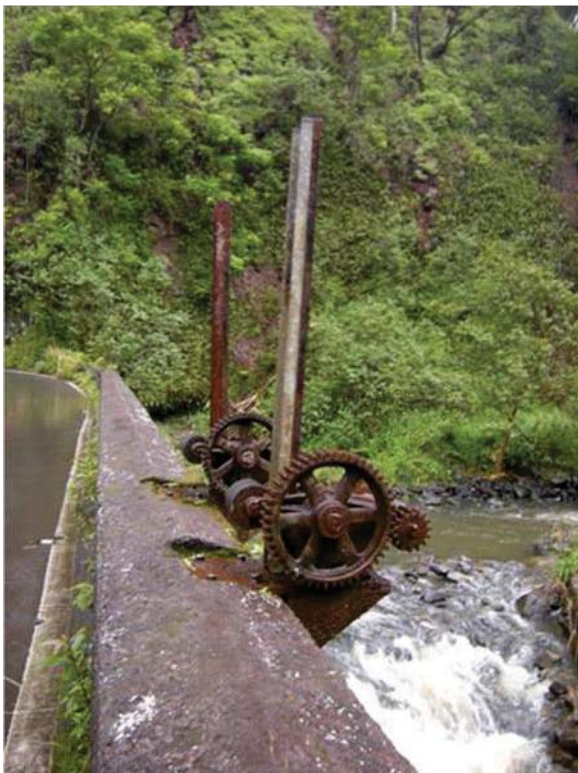
Figure 28: This sluice gate mechanism is a geared type. It operates by attaching a crank to the shaft of the small pinion gear. Revolving the crank operates the geared mechanism and advances the gear rack, to raise or lower the gates. This geared-operating gate is located at EMI stream diversion at Kopiliula, which is ordered to be restored as a “Habitat Stream” by CWRM. View facing E. (Source: MAI, 2018.)

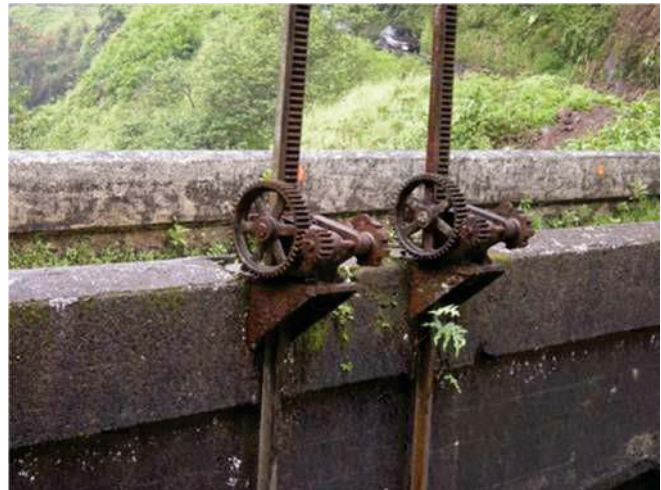
Figure 29: View of the same geared mechanism at right.

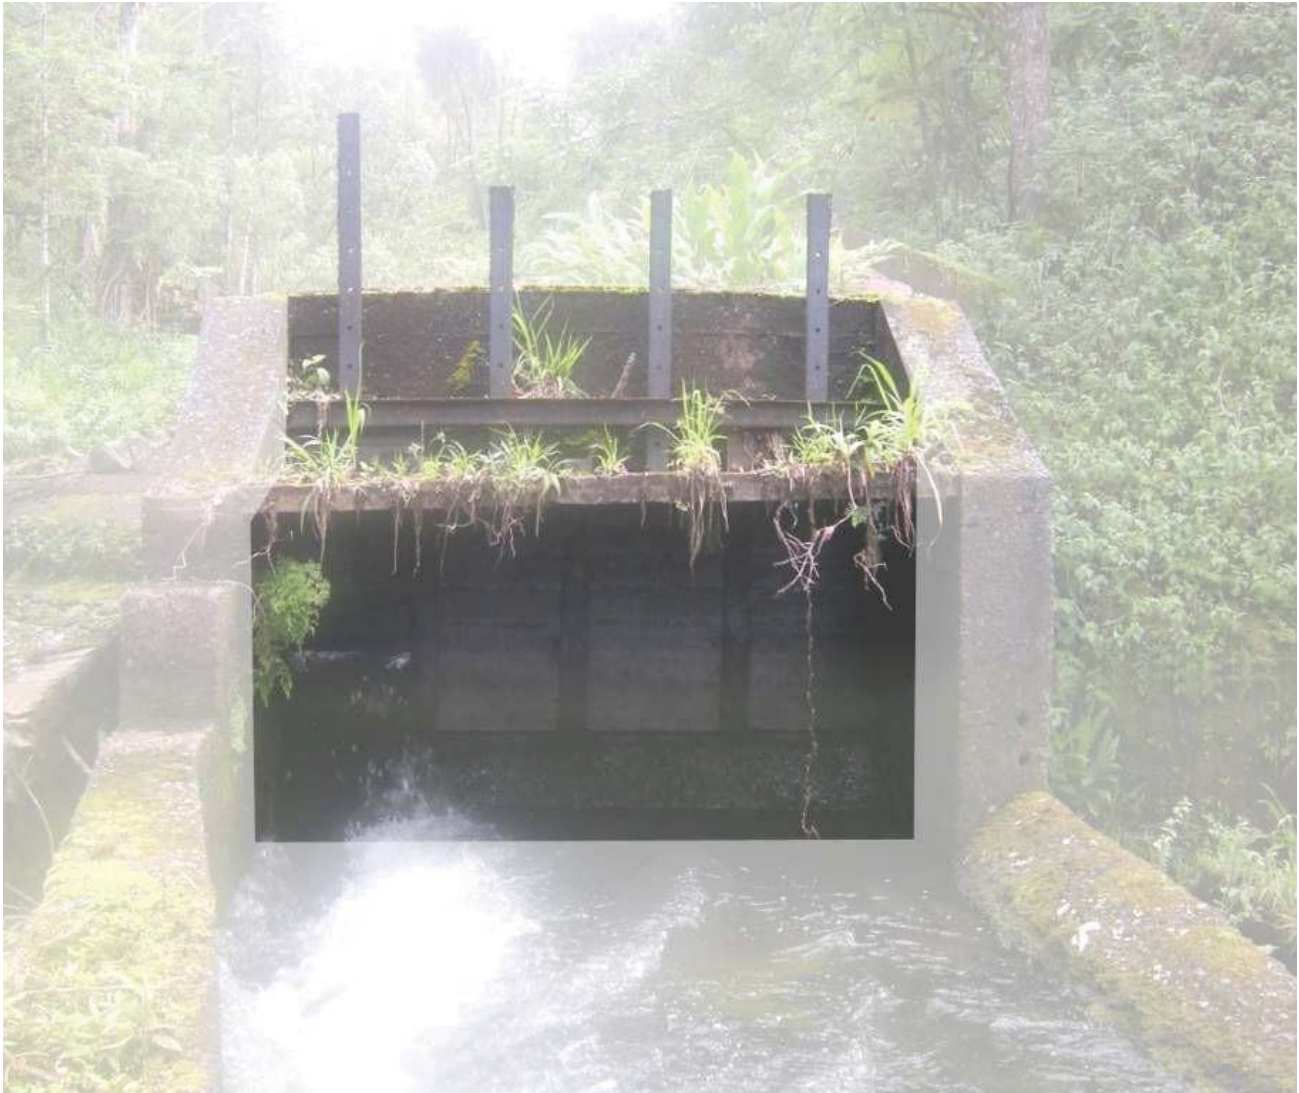
Figure 30: This typical board adjusted type sluice gate operating mechanism is located at EMI Kolea Power House stream diversion on Kolea, a tributary of Punalau, which is ordered to be restored as a “Habitat Stream” by CWRM. View facing SW. (Source: MAI, 2018.)

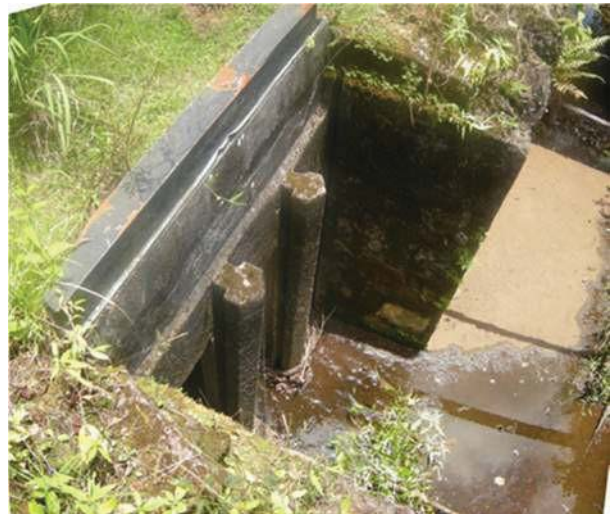
Figure 31: Board adjusted sluice gate with no boards installed. Note that this gate is about 5' wide in total, with three vertical spaces for boards. This board adjusted gate is located at EMI throw-out gate at Piinaau, which is ordered to be a "Fully Restored" stream by CWRM. View facing NE. (Source: MAI, 2018.)

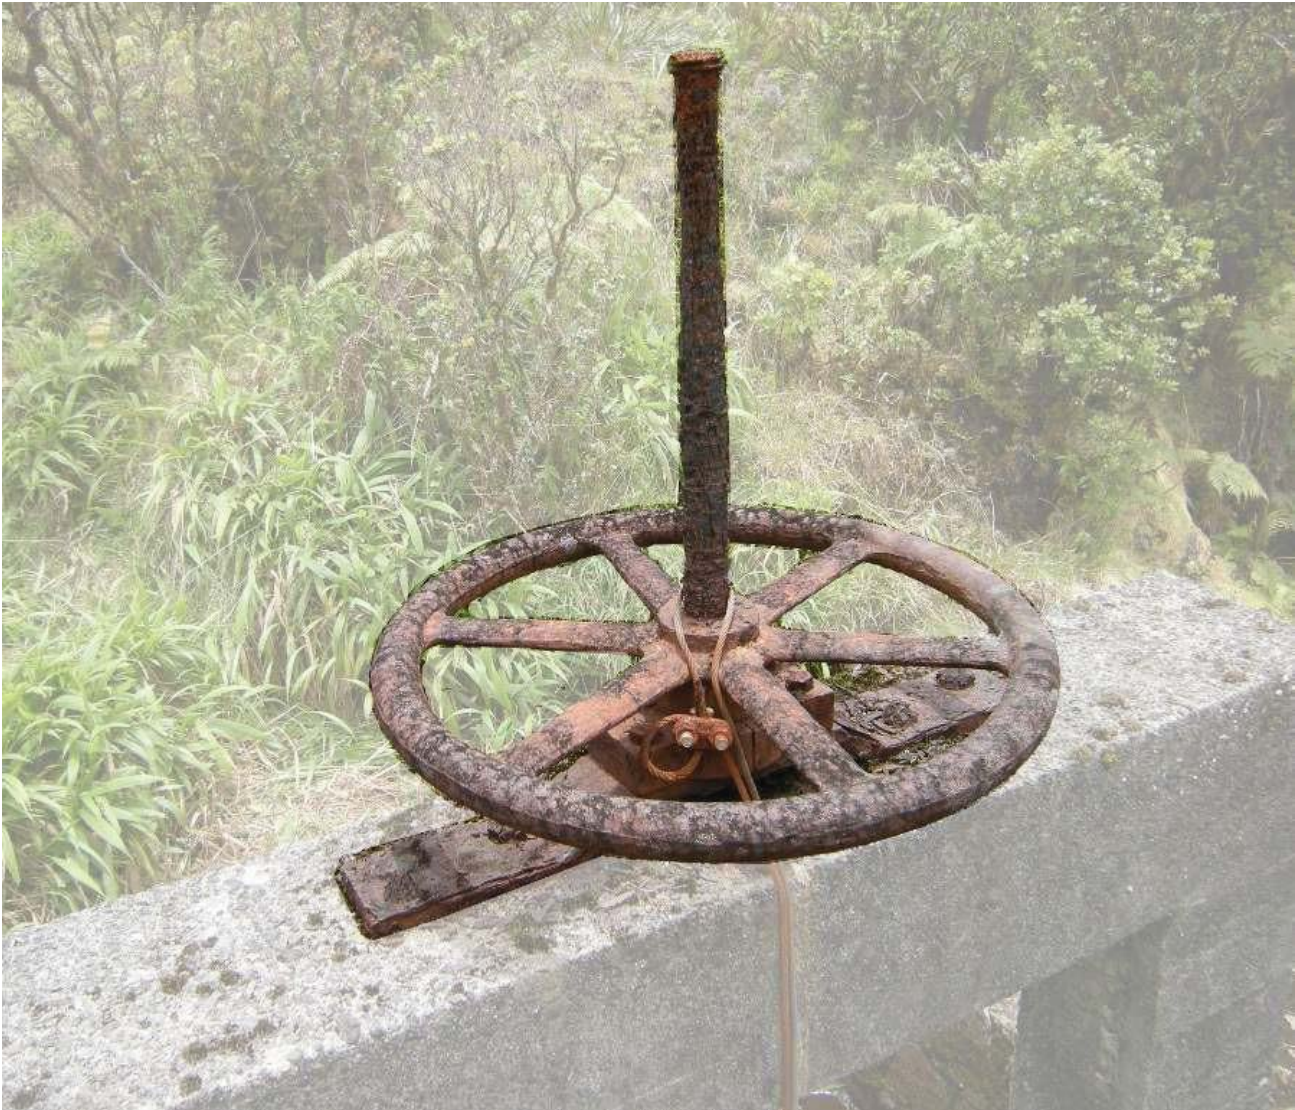
A gate mechanism using a vertical threaded shaft was seen on one of the thirty-one sluice gates. The shaft was fixed to the top of the solid panel gate and was operated by a handwheel that could advance the shaft and gate up or down. The single example of this type of sluice gate seen, was inoperable due to a missing handwheel and severely corroded threaded shaft. Some of these mechanisms have become inoperable due to lack of use. When necessary, however, they can be serviced to make the adjustments to diversions for regulatory compliance.

Figure 33: This threaded shaft type sluice gate operating mechanism is located along an irrigation ditch on the Big Island. It is very similar to the threaded shaft mechanism observed at EMI Kolea Power House stream diversion, on Kolea, a tributary of Punalau, which is ordered to be restored as a “Habitat Stream” by CWRM. The single example surveyed was too damaged to properly illustrate its configuration. (Photo: MAI, 2017.)

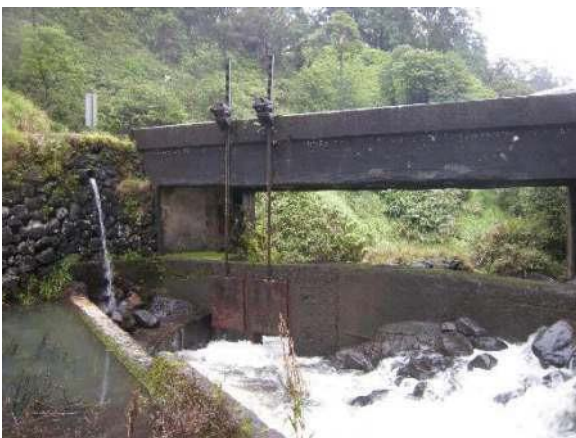
Figure 3: Geared sluice gate at Ko Piliula stream diversion dam. (Two sluice gates shown, side-by-side.) Eligible for the Hawaii Register as a contributing feature to a potential district. Integrity largely retained. View facing N. (Source: MAI, 2018)

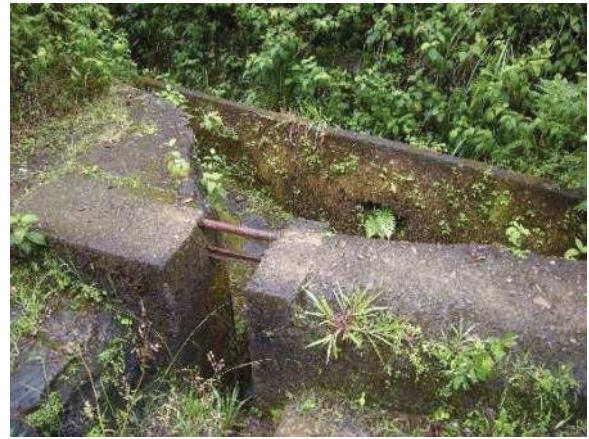
Figure 6: Board adjusted sluice gate throw out at intake of Wai O Hue stream diversion. Eligible for the Hawaii Register as a contributing feature to a potential district. Integrity largely retained. View facing SE. (Source: MAI, 2018)

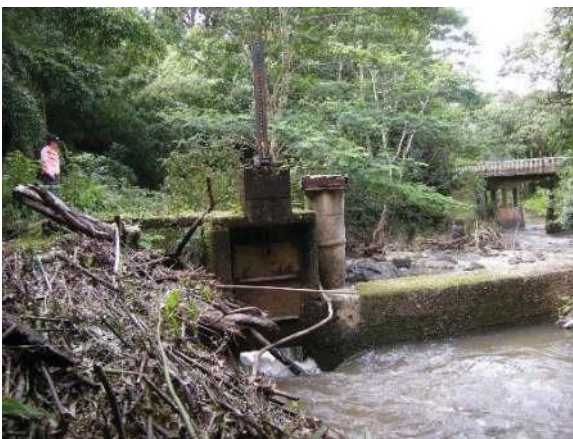
Figure 7: Ratchet sluice gate at Na Ili Ili Haele stream diversion dam. Eligible for the Hawaii Register as a contributing feature to a potential district. Integrity largely retained. View facing NW. (Source: MAI, 2018)

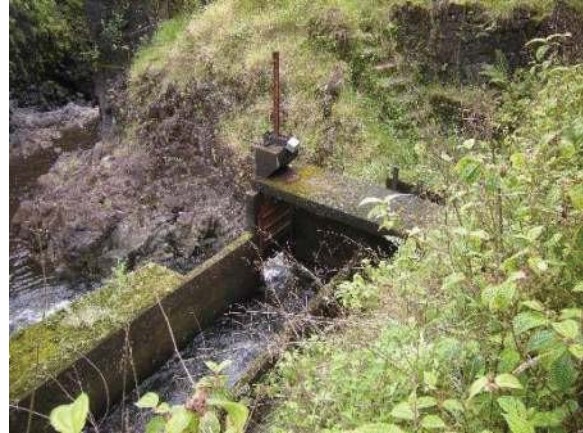
Figure 10: Ratchet sluice gate at Wailua Iki West stream diversion. Eligible for the Hawaii Register as a contributing feature to a potential district. Integrity largely retained. View facing N. (Source: MAI, 2018)

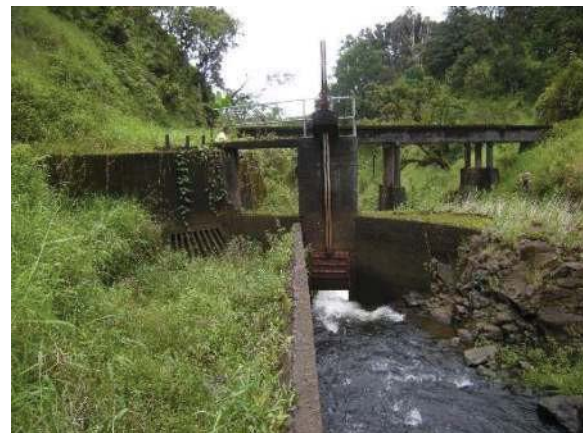
Figure 12: Ratchet sluice gate at Wailua Iki East stream diversion dam. Eligible for the Hawaii Register as a contributing feature to a potential district. Integrity largely retained. View facing NE. (Source: MAI, 2018)

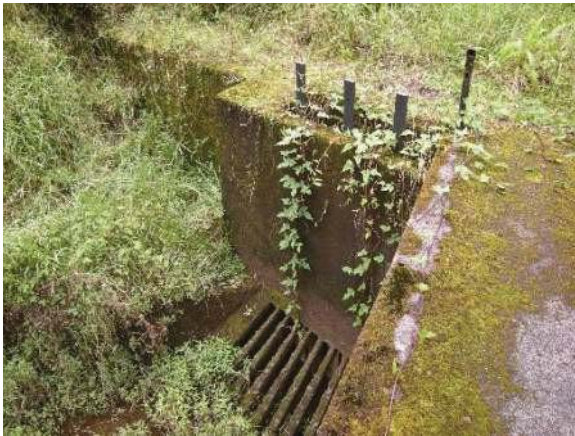
Figure 13: Board adjusted sluice gate at intake of Wailua Iki East stream diversion. Eligible for the Hawaii Register as a contributing feature to a potential district. Integrity partially retained. View facing NW. (Source: MAI, 2018)

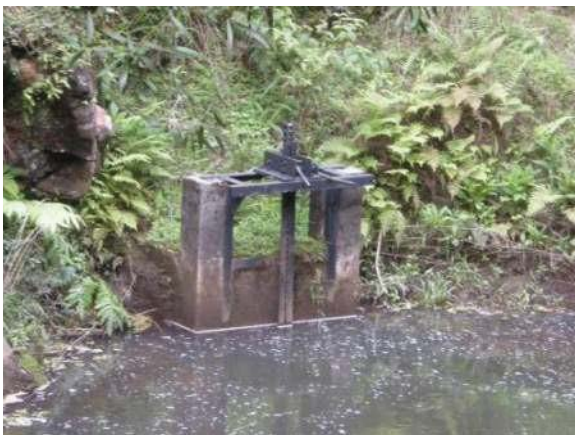
Figure 15: Ratchet sluice gate at intake at Hoolawa Haiku stream diversion. Eligible for the Hawaii Register as a contributing feature to a potential district. Integrity partially retained. View facing E. (Source: MAI)

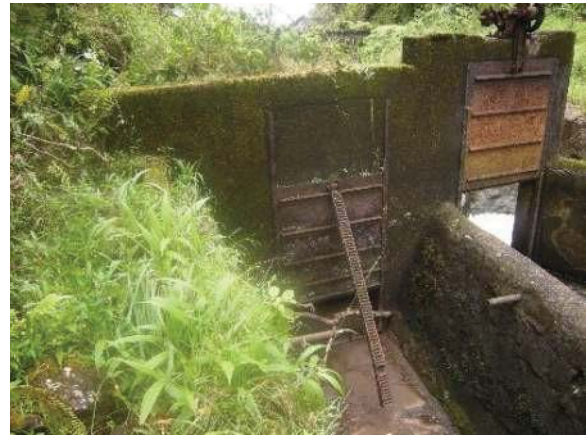
Figure 18: Geared sluice gate at intake at Honomanu stream diversion. Eligible for the Hawaii Register as a contributing feature to a potential district. Integrity largely retained. View facing E. (Source: MAI, 2018)

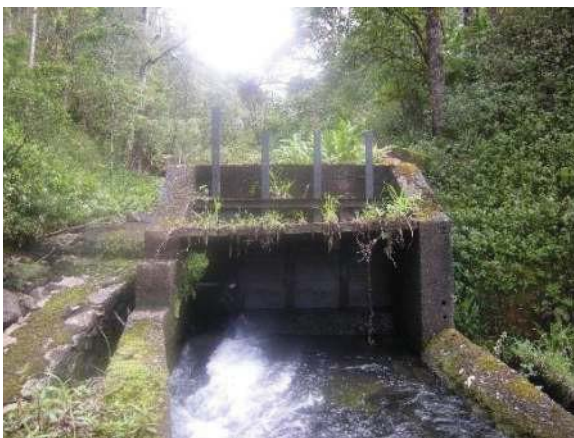
Figure 39: Board adjusted sluice gate at intake of Kolea Power House stream diversion. Eligible for the Hawaii Register as a contributing feature to a potential district. Integrity partially retained. View facing W. (Source: MAI, 2018)

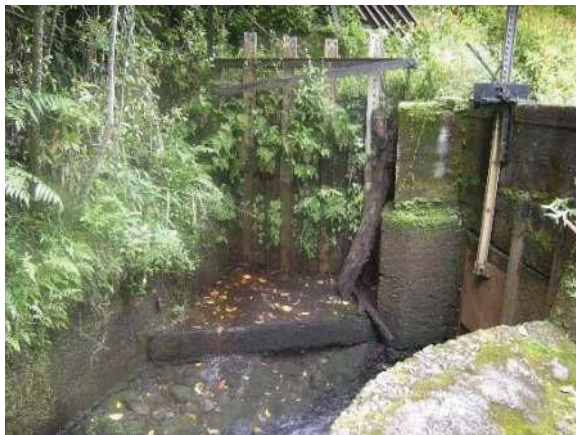
Figure 23: Board adjusted sluice gate (on left) at intake of Hoalua stream diversion. Eligible for the Hawaii Register as a contributing feature to a potential district. Integrity partially retained. View facing NE. (Source: MAI, 2018)

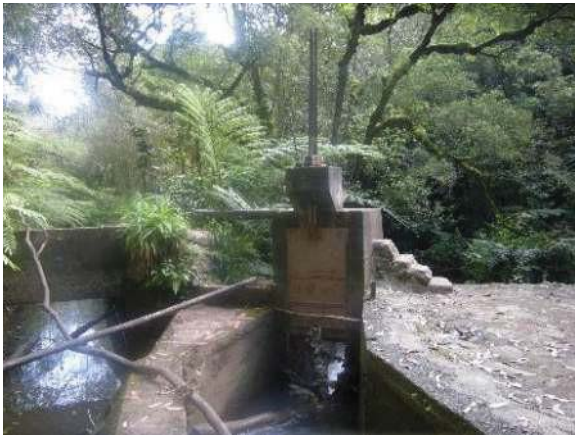
Figure 25: Ratchet sluice gate at Hoolawa Lii Lii stream diversion dam. Eligible for the Hawaii Register as a contributing feature to a potential district. Integrity largely retained. View facing NE. (Source: MAI, 2018)

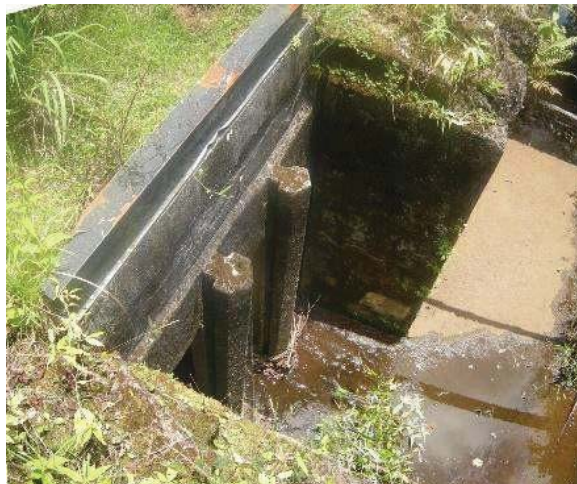
Figure 27: Board adjusted throw out sluice gate at Piinaau throw out. Eligible for the Hawaii Register as a contributing feature to a potential district. Integrity largely retained. View facing NE. (Source: MAI, 2018)

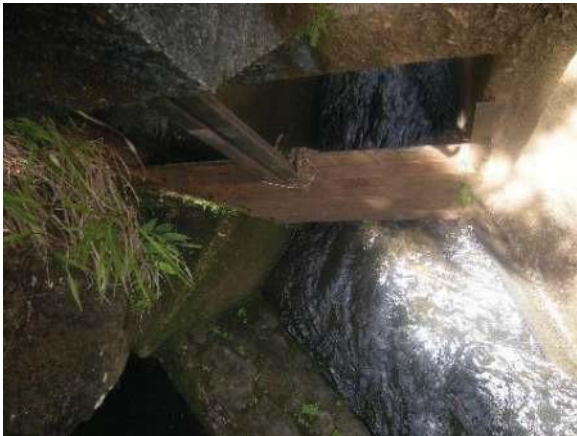
Figure 29: Ratchet sluice gate at Wai Ka Moi stream diversion dam. Eligible for the Hawaii Register as a contributing feature to a potential district. Integrity largely retained. View facing NW. (Source: MAI, 2018)

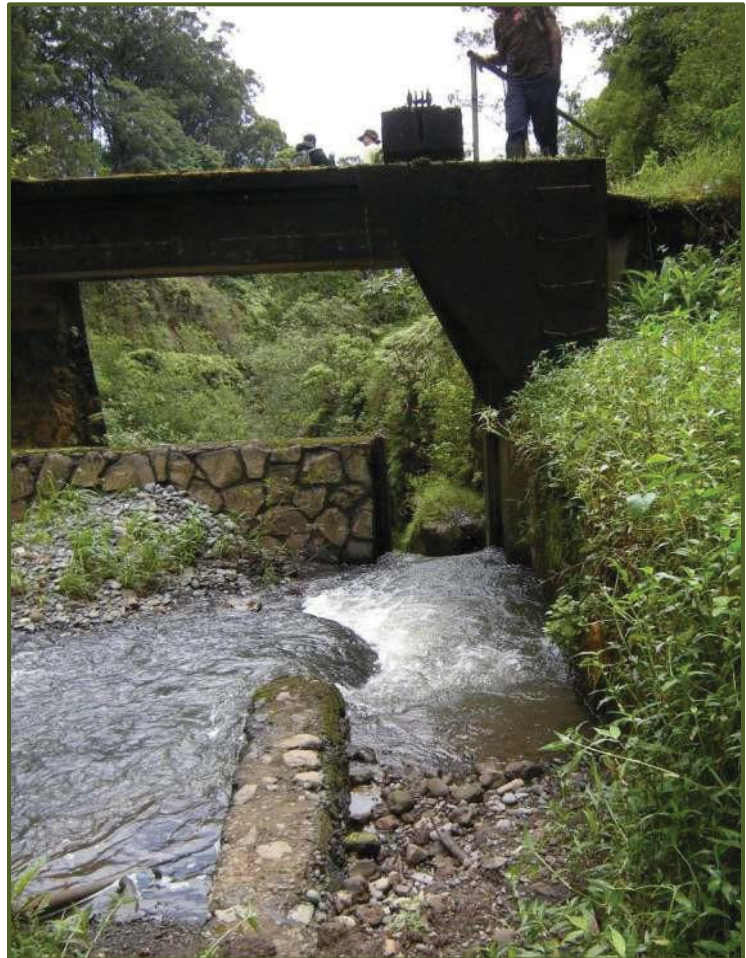
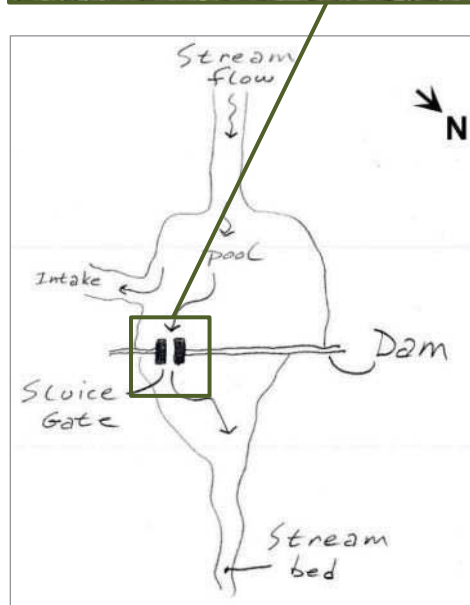
WAILUA NUI WEST

Removed sluice gate (ratchet) at Wailua Nui West stream diversion dam. View facing NE.

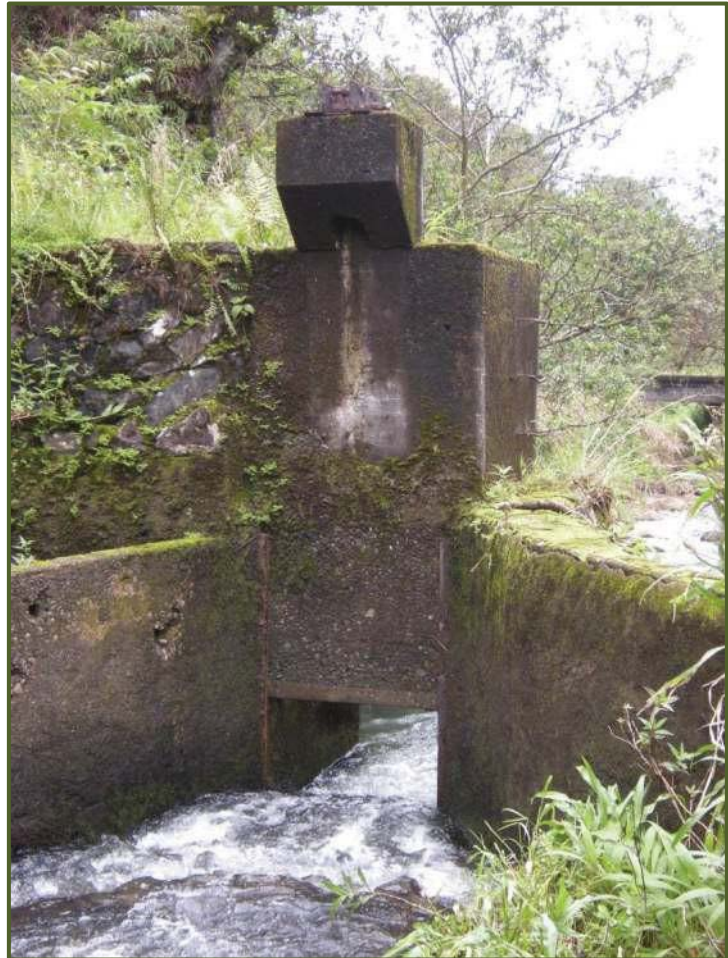
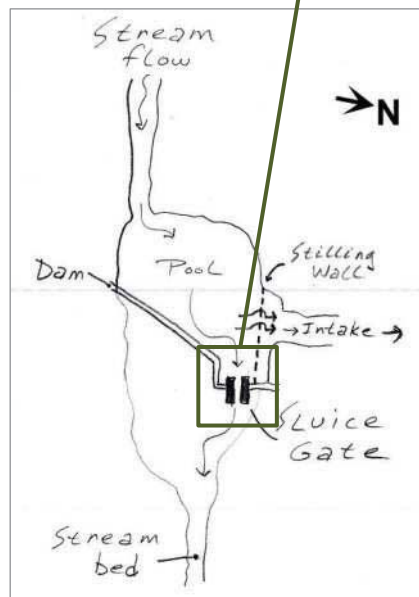
WAILUA NUI EAST

Removed sluice gate (ratchet) at Wailua Nui East stream diversion dam. View facing NE.

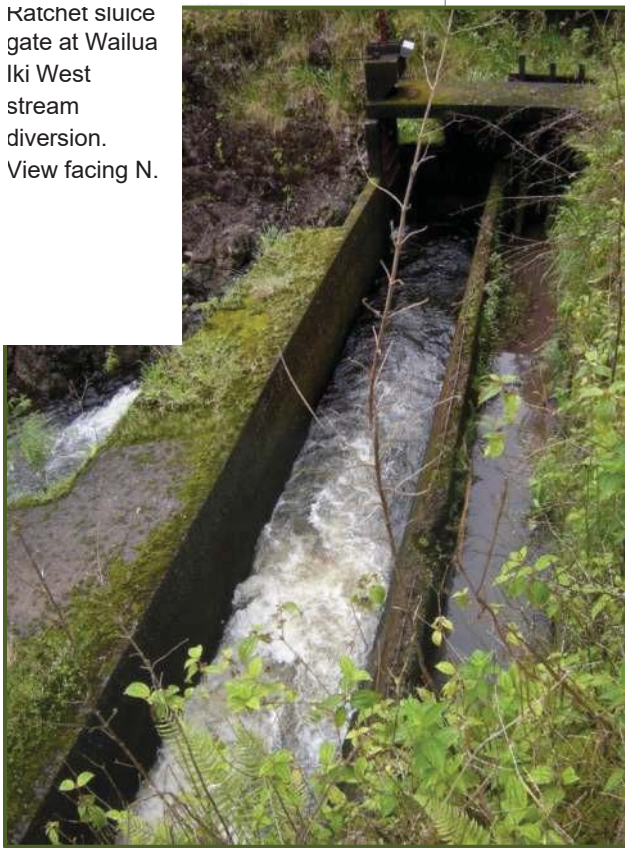
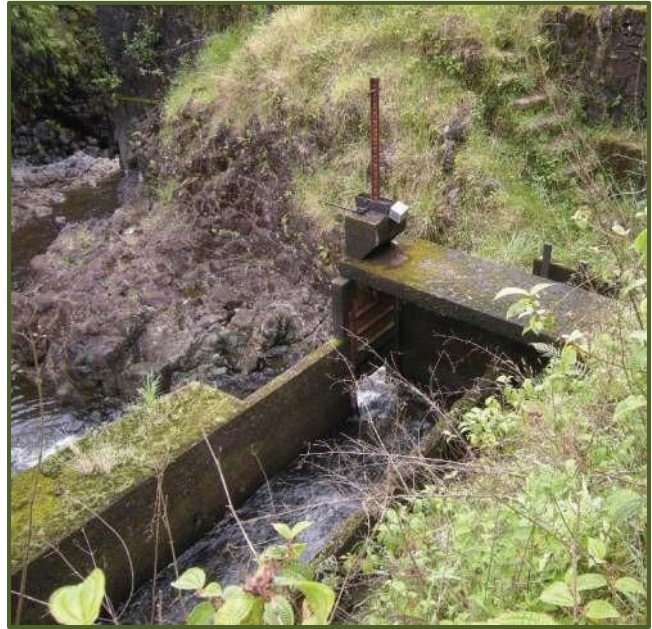
WAILUA IKI WEST

Ratchet sluice gate at Wailua Iki West stream diversion. View facing N.

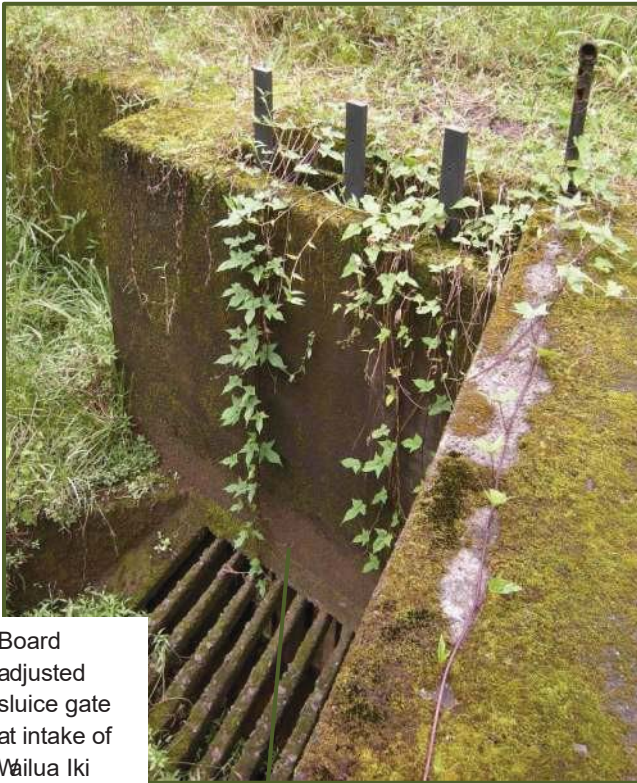
WAILUA IKI EAST

Board adjusted sluice gate at intake of Wailua Iki East stream diversion. View facing NW.

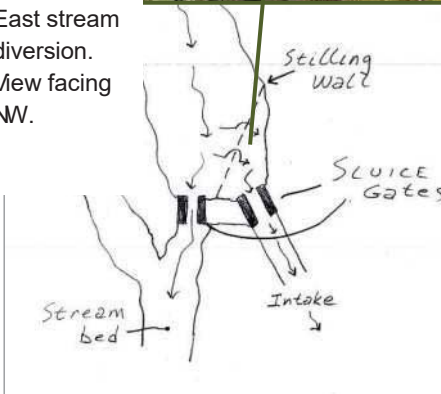
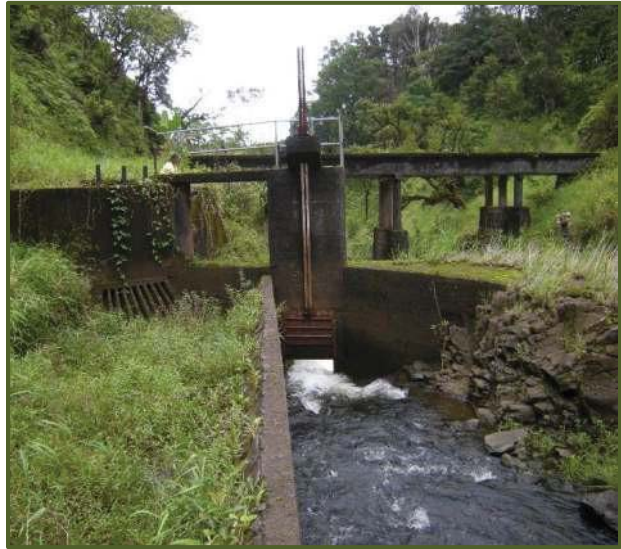
Ratchet sluice gate at Wailua Iki East stream diversion dam. View facing NE.

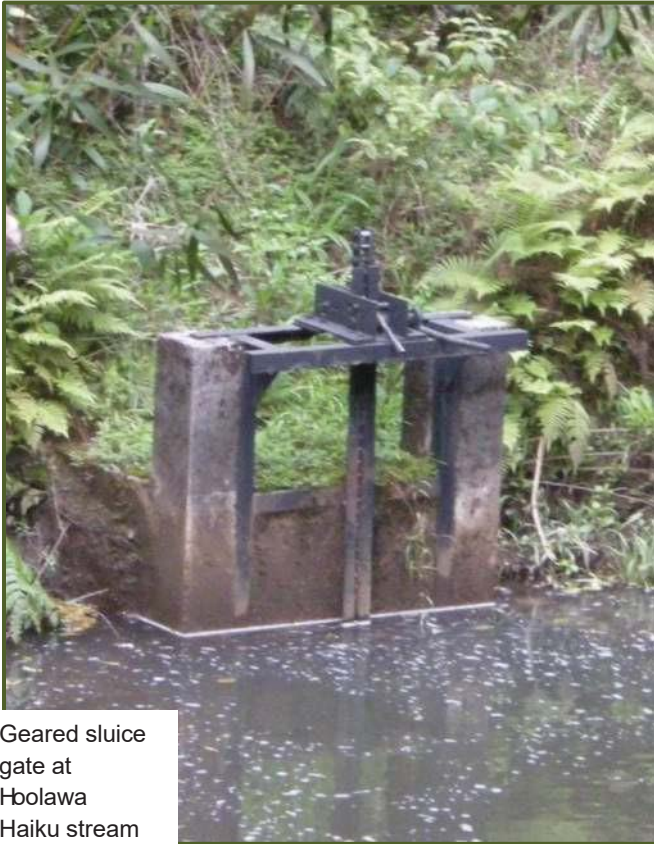
HOOLAWA HAIKU

Geared sluice gate at Hoolawa Haiku stream diversion dam.

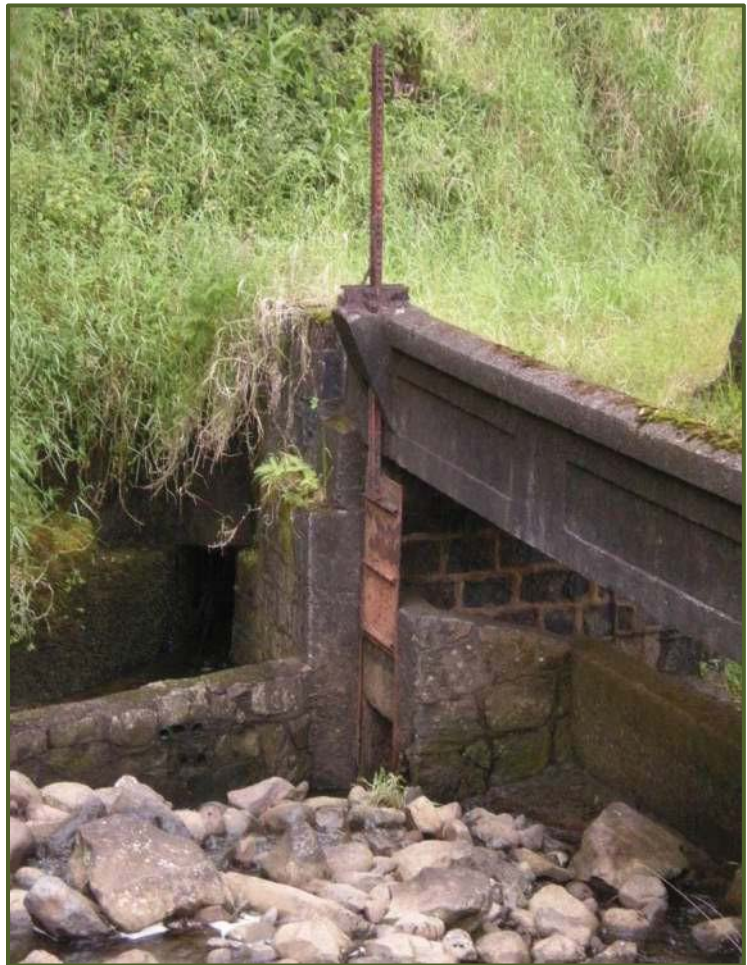
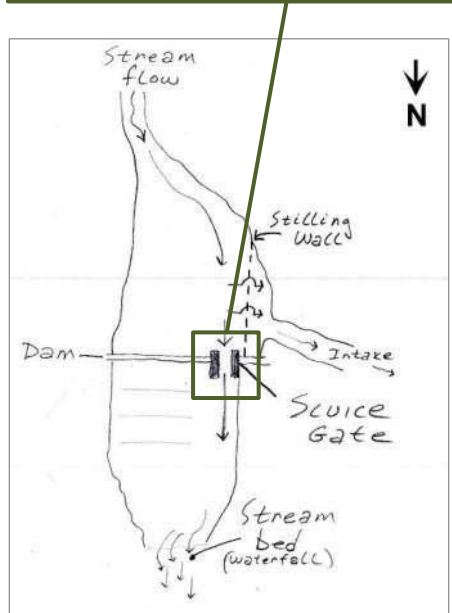
BANANA INTAKE

Ratchet sluice gate at
Banana Intake stream
diversion dam. View
facing NW.

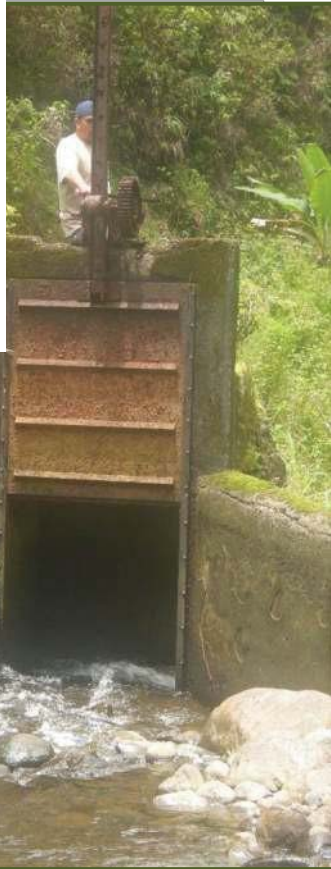
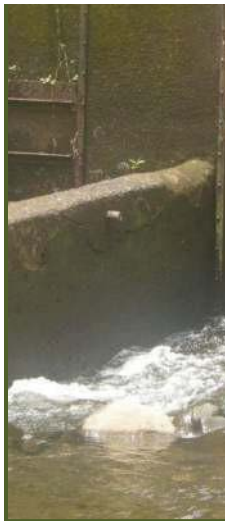
HONOMANU

Geared sluice gate at intake at Honomanu stream diversion. View facing E.

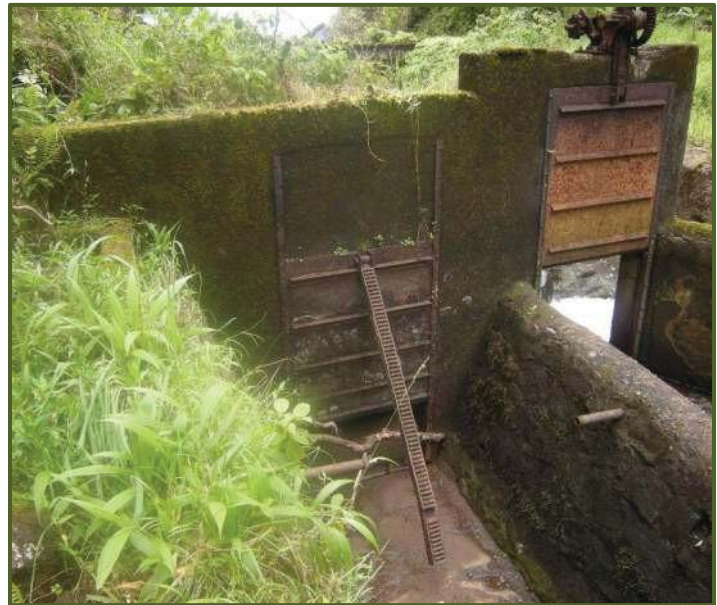
Geared sluice gate at Honomanu stream diversion dam. View facing N.

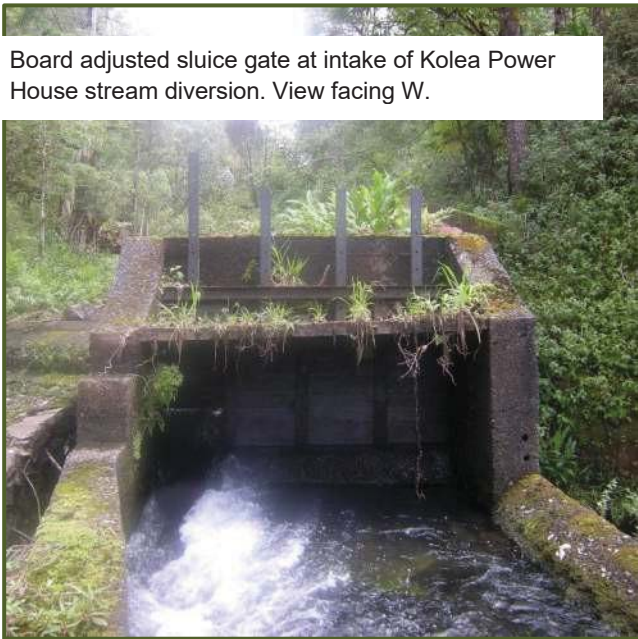
KOLEA POWER HOUSE

Board adjusted sluce gate at intake of Kolea Power House stream diversion. View facing W.

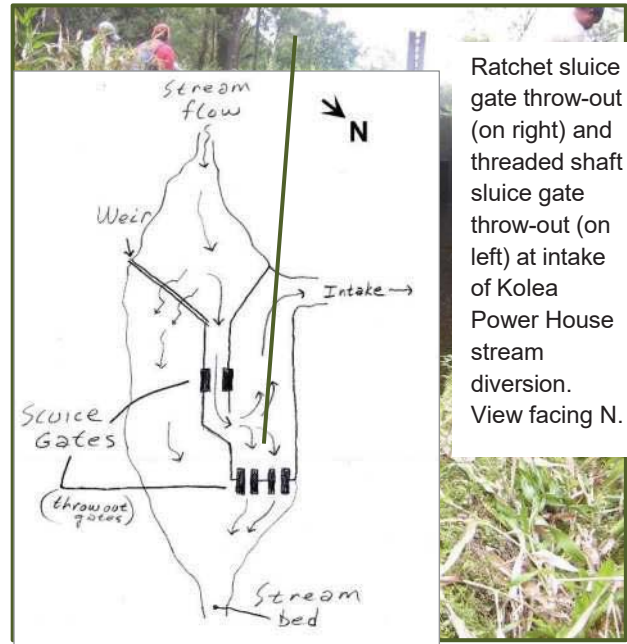
Ratchet sluce gate throw-out (on right) and threaded shaft sluce gate throw-out (on left) at intake of Kolea Power House stream diversion. View facing N.

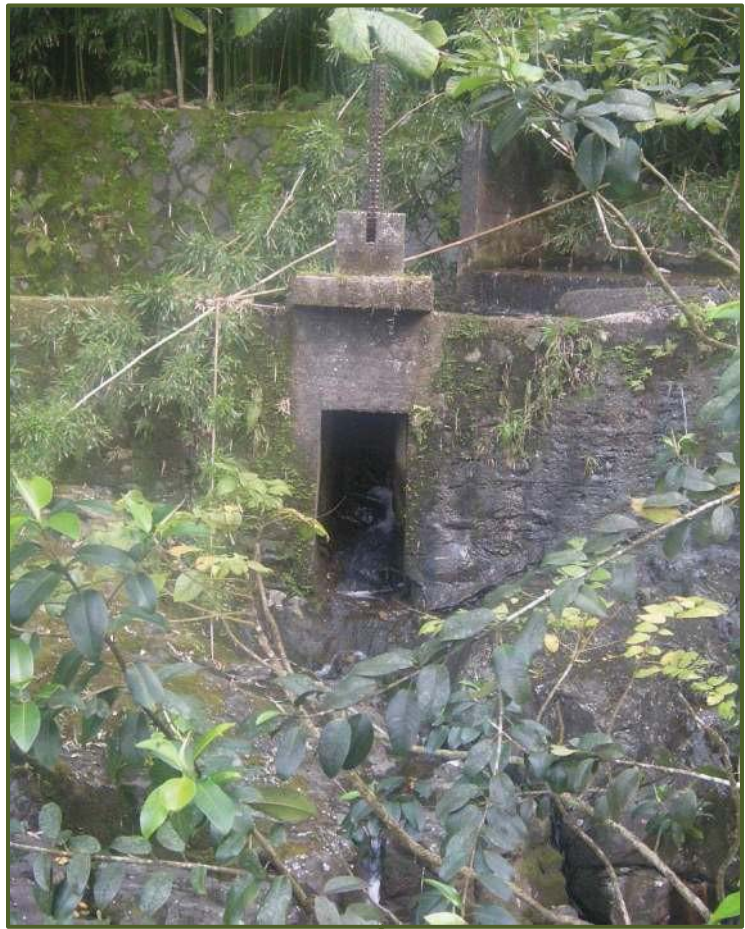
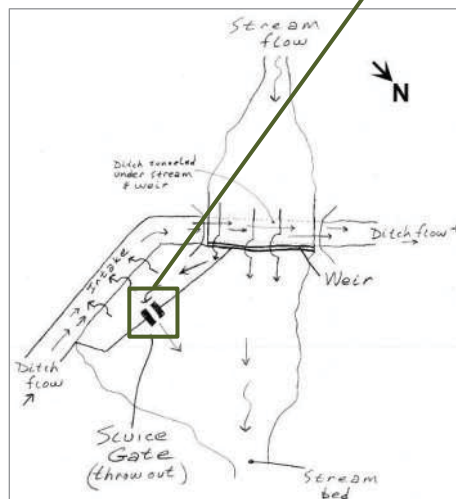
KAAIEA

Ratchet sluice gate
throw-out at Kaaiea
stream diversion.
View facing S

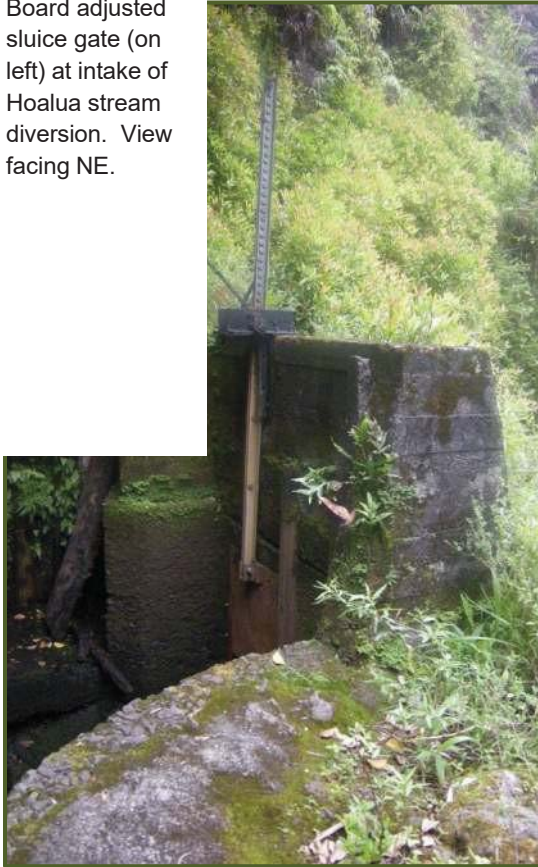
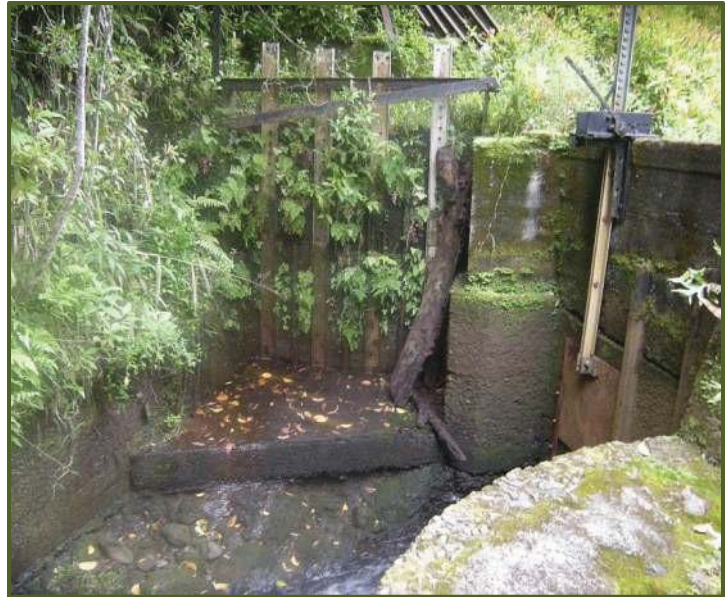
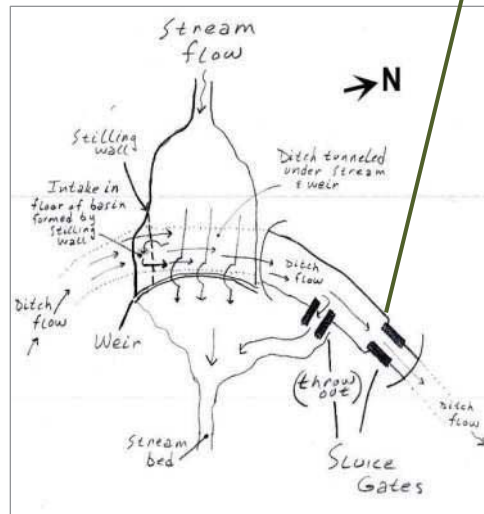
HOALUA

Board adjusted sluice gate (on left) at intake of Hoalua stream diversion. View facing NE.

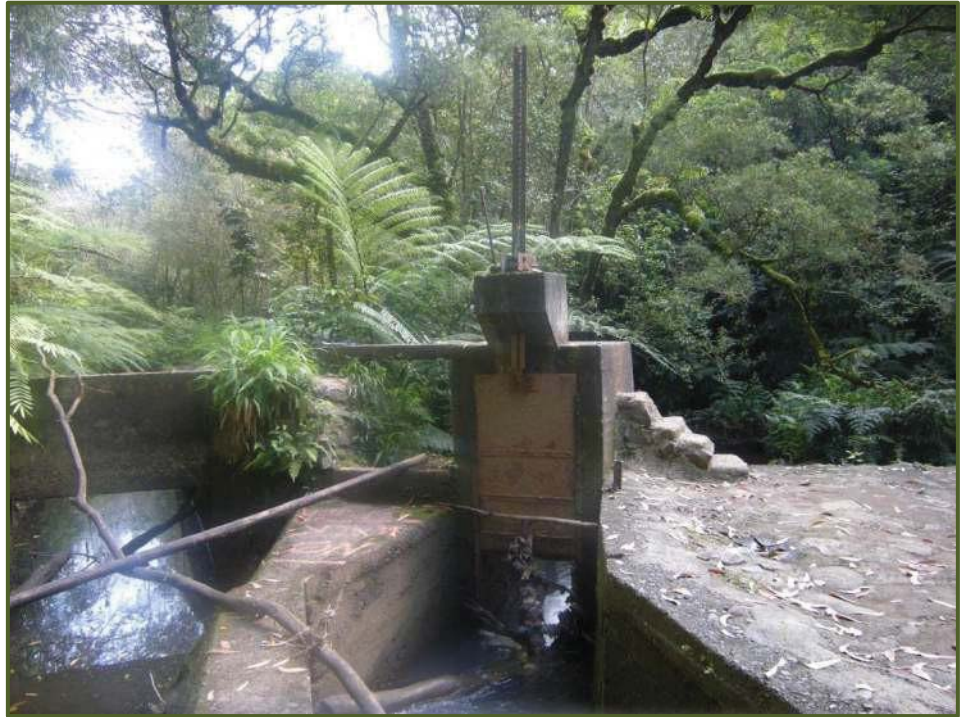
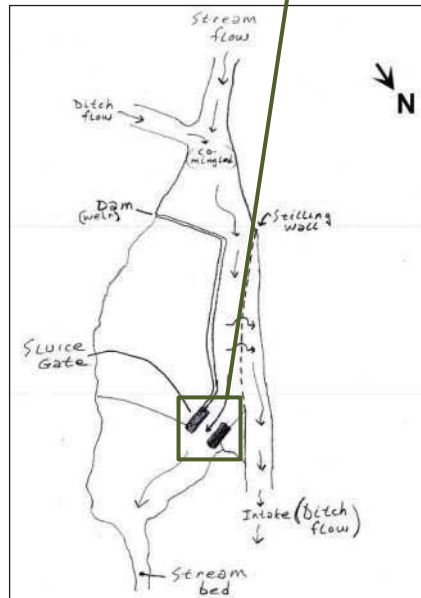
HOOLAWA LII LII

Ratchet sluice gate at Hoolawa Lii Lii stream diversion dam. View facing NE.

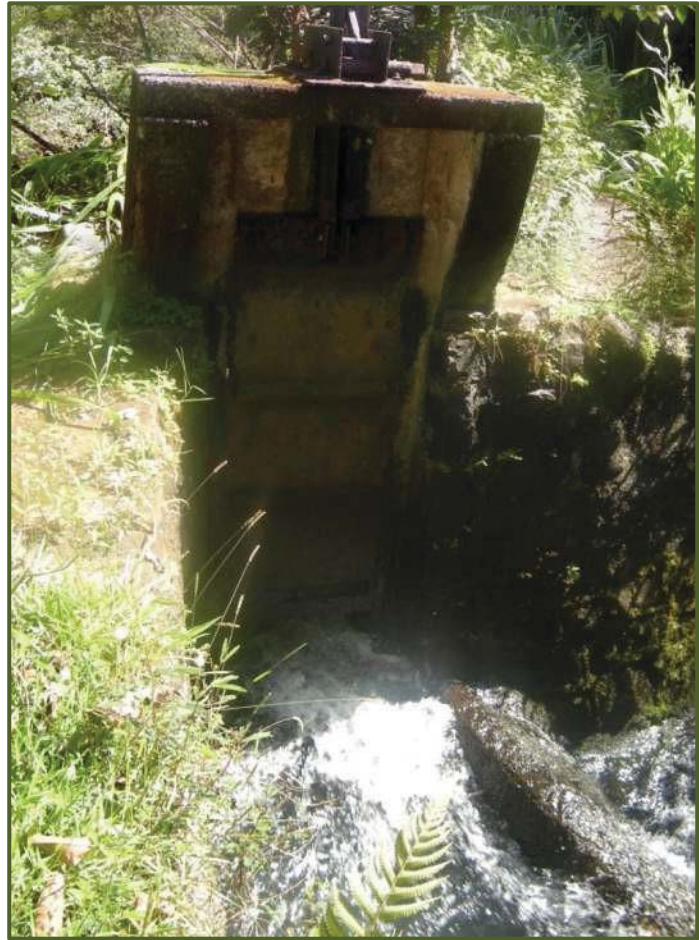
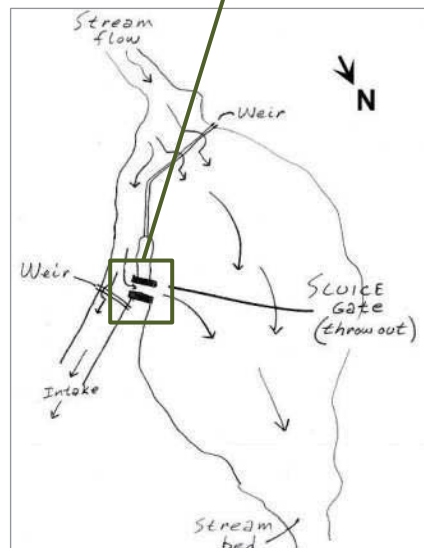
HOOLAWA NUI

Ratchet sluice gate
throw-out at intake
of Hoolawa Nui
stream diversion.
View facing S.

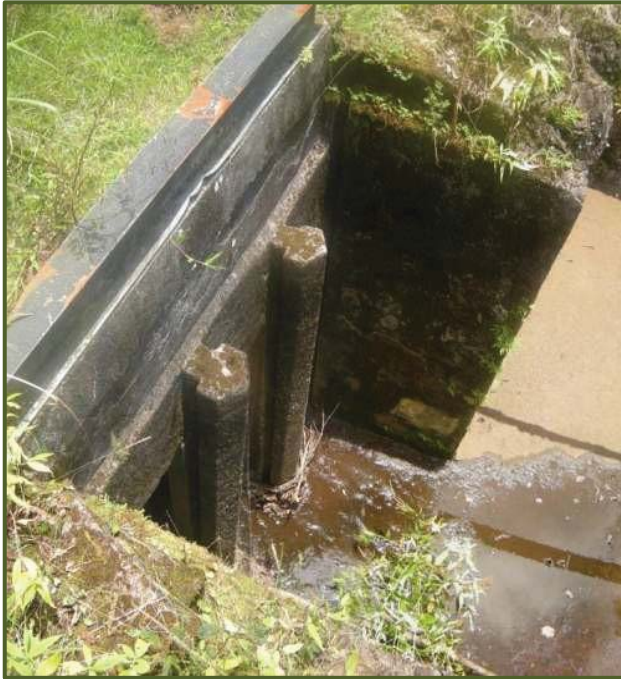
PII NAAU

Board adjusted throw-out sluice gate at Piinaau throw-out. View facing NE.
