Historical Structure Assessment

East Maui Aqueduct System

Mason Architects, Inc.

April 2019

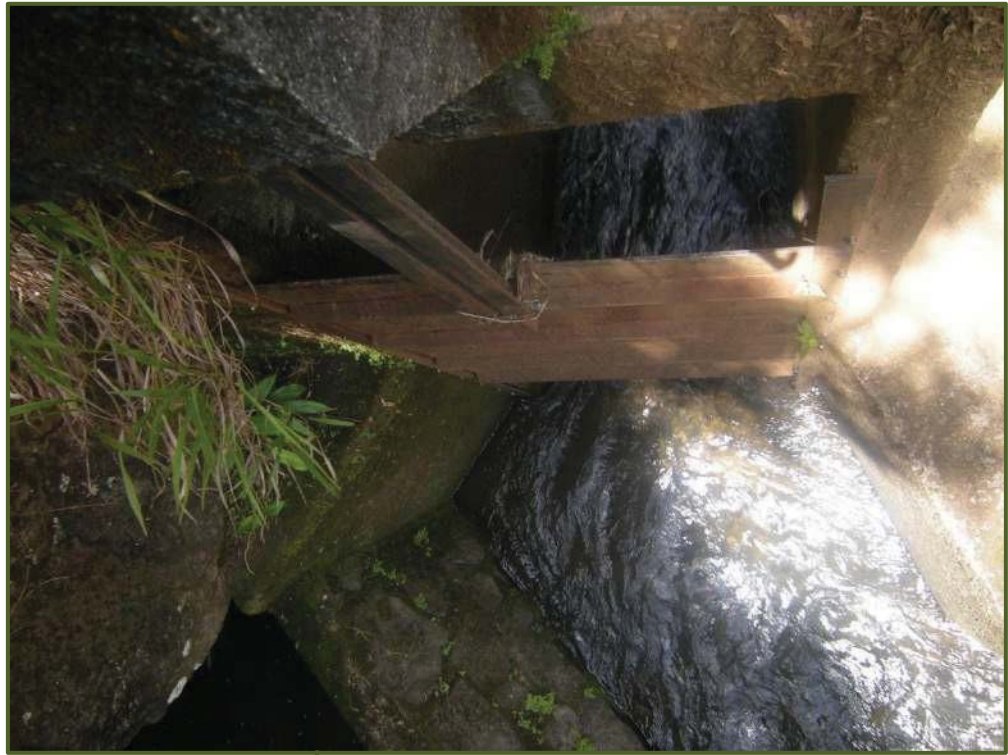
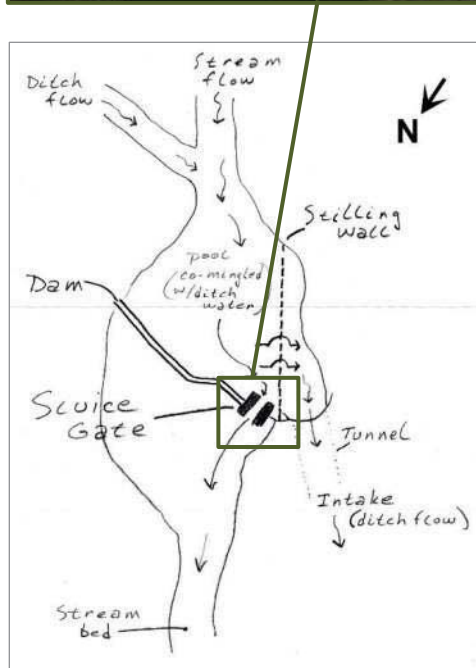
WAI KA MOI

Ratchet sluice gate at Wai Ka Moi stream diversion dam. View facing NW.

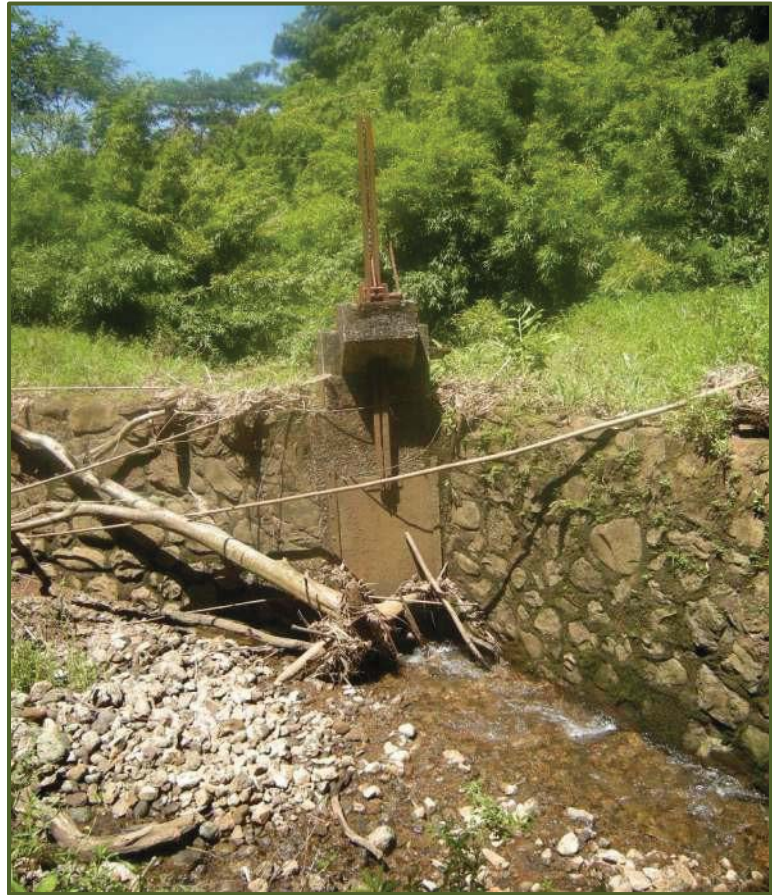
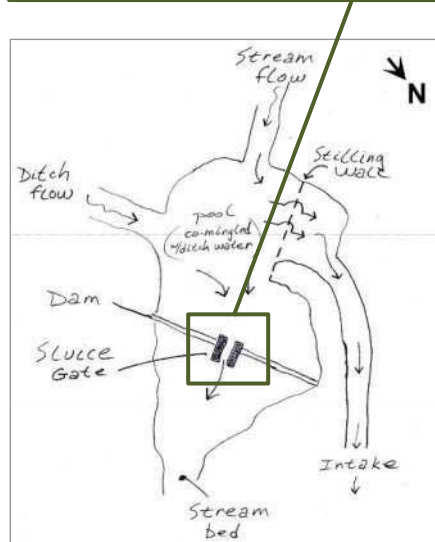
KOLEA

Ratchet sluice gate at Kolea stream diversion dam. View facing NE.
